THE PROJECT DREDGDIKES: CHARACTERIZATION OF CHEMICAL PROPERTIES OF THE DREDGED MATERIAL AND FIRST RESULTS ON VEGETATION MONITORING

Abstract. In the South Baltic cooperation project DredgDikes different dredged materials are investigated to be used in dike construction. In Rostock, focus is given to uncontaminated fine-grained organic dredged materials from the Warnow river delta, dewatered and ripened on the Hanseatic City of Rostock's containment areas. The treatment facility in Rostock only collects material which complies with the precautionary values of the German federal soil protection and contaminated site ordinance (BBodSchV, 1999) and thus is allowed to be reused. Three different dredged materials were analysed and a large-scale experimental dike has been built with different geosynthetic solutions. Coastal protection structures made of earth material have to possess a strong and close vegetation cover to reinforce the stability of dike constructions during flood events. Only this - maybe in connection with geosynthetic rolled erosion control products (RECPs) - offers protection against erosion and reduces the infiltration of water in the dike body. On both the dike and e

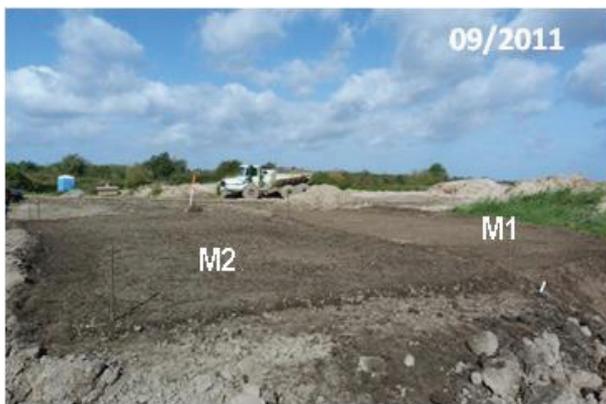
**Fig 9.** Prepared compaction testing field

After the construction of the compaction testing fields with three-dimensional reinforcement mat (herein after referred to as 3D-RM) against cracking (60 cm and/or 30 cm below ground) in September 2011 the surface of the two materials was roughened about 2 cm deep. The seeds was spread evenly, raked in and fixed with a roller (Fig 9). In October 2013 the root penetration at the compaction testing field was determined. For this purpose on the M1 and M2 fields 60 cm deep profiles were dug and the root penetration in the excavated material as well as at the profile walls were checked. Furthermore cracks were detected and documented photographically to assess the functionality of the 3D-RM.

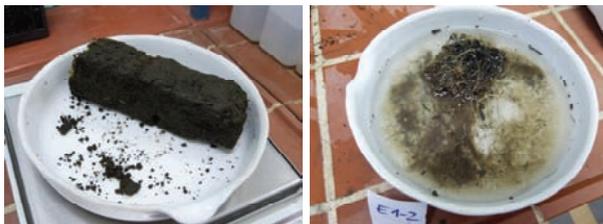
Fig 10. a) Prepared sample for watering, b) Connected root system for further preparation

The samples were dried to mass constancy at room temperature, weighed and stored for future treatment. A further step will be the ashing by 500°C in the muffle furnace for evaluating the ashless root mass. Conclusions for the comparison of the different materials and the effects of erosion products for the root development are expected.

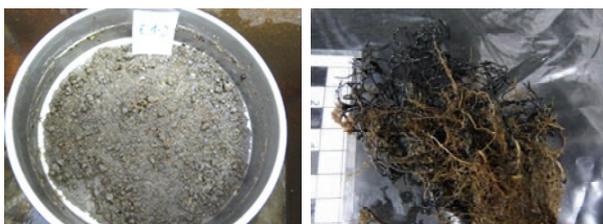
Fig 11. a) Soil and stones, rests of roots and organic material in the sieve, b) Washed out root system with rooted RECP

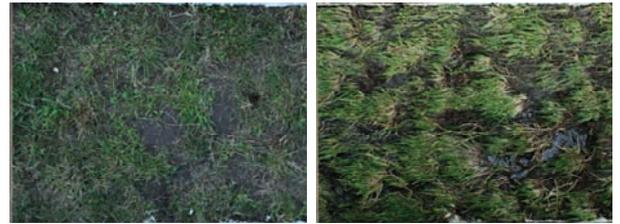
Fig 12. Cross section D (52 x 38 cm), flume 1, section 6, a) Initial situation b) After 4th overtopping

The problem of comparing the different sections is to estimate the damages at the initial situation and after overtopping events (see Fig 12 and 13). A digitalization that will enable the estimation of damages is always a subjective procedure because there are no clearly visible edges. Other difficulties are the mowing rests at the beginning and the grass, which lie down due to the water flowing and partly covers the damages.

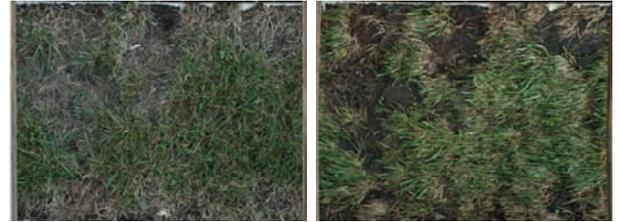
Fig 13. Cross section E (52 x 38 cm) with erosion mat, flume 1, section 6, a) Initial situation b) After 4th overtopping

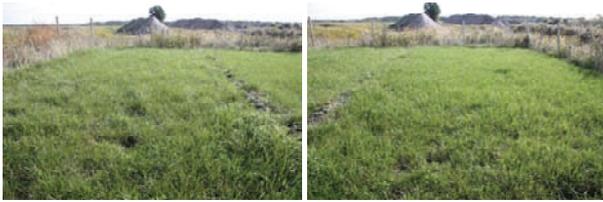
Fig 14. Turf in September 2013 of the compaction testing fields a) Material M1 b) Material M2

The autumn sowing verified the spring results from the seeding pre-test. A fast sprout of the variation 2 mixture was observed. An adequate pre-winter growth provided a development of a vital and compact vegetation cover in the following vegetation period (**Fig 14**). The increased growth of the cultivars was documented by 4 necessary cuts in 2012. Between the two substrates M1 and M2 no significant growth differences could be observed. The amount of legumes was broadly similar in the first year after seeding, but in 2013 the amount of legumes was significant higher in M2 than in M1. Lesch (2012) made an analogue observation with these two materials.

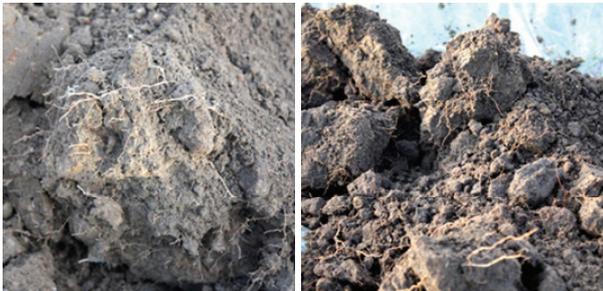
Fig 15. Soil layer 20 to 30 cm, a) Material M1 b) Material M2

The excavation in October 2013 showed a rooting of the whole horizon (< 0.6 m). In material M1 the rooting clearly decreased below the first 30 cm depth. Also in the topsoil 0 to 30 cm of depth in M1 the amount of roots was clearly lower. Also few legumes roots were found in this horizon. This could be traced back to the fact of a low proportion of legumes (leaf area density) at the surface of M1. However, fine roots were also found in the layer of 60 cm. The root

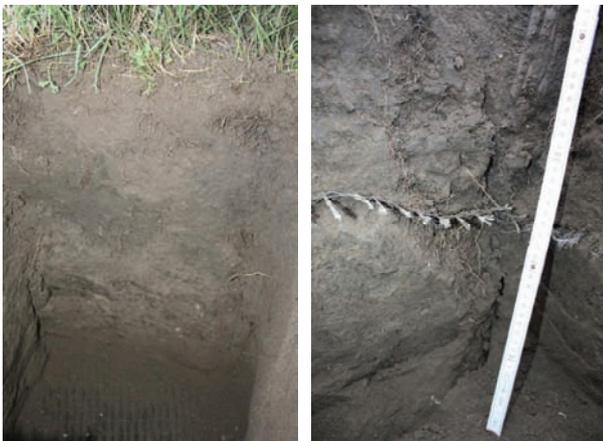
Fig 17. a) Material M1 soil horizon depth 60 cm (3D-RM), b) Material M2 3D-RM in 30 cm depth (visible rooting and cracking)

Apparently the cracking could not be avoided by the 3D-RM. Above and beneath the 3D-RM cracks penetrated with branched roots could be observed. The width of the observed cracks differs from few mm to 2 cm.

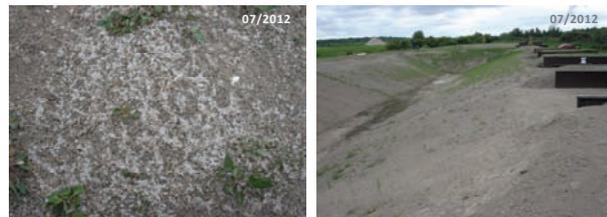
Fig 18. Surface of test dike two weeks after hydro-seeding, a) Decomposed binder b) Beginning saltbush growth

At the test dike the hydro-seeding failed at the beginning. After a first slight growth of grass an extensive saltbush (*Atriplex*) vegetation cover developed on parts of the test dike.

The continuous aridity led to a loss of germinating seed during the summer, covering only 20 % to 50 % of the area (Fig 18). The seeding and re-seeding of blank areas by hand in August didn't result in a complete vegetation cover before September. Only with significantly higher precipitation at the beginning of October and the reduced evaporation the growth of the grasses and legumes improved considerably (Fig 19a). The vegetation development in spring 2013 was inhibited by a long and strong winter. After the melting of the snow cover (till April) the young grasses in the re-sowing areas were visible. The grasses endured the winter quite well. In some areas the protective snow was blown away resulting in the freezing and death of the vegetation. The soil was dried by the dry freeze and the topsoil was like fine grained powder (the same situation as at the compaction testing field). The vegetation recovered with increasing temperatures in May and within some weeks a relatively close vegetation cover was established. (Fig 19b). However, with increasing temperatures the activity of voles rises (Fig 20a).

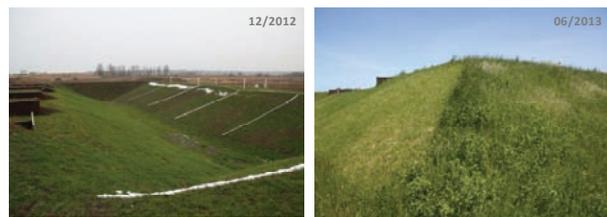
Fig 19. Turf development at the test dike a) polder 2 in 2012 b) polder 1 in 2013 freshly mowed (left)

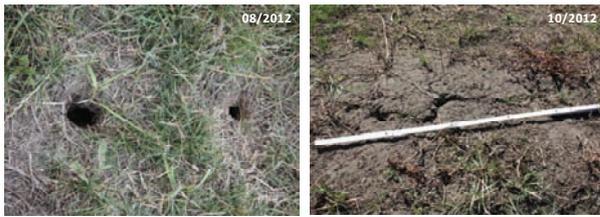
Fig 20. a) Activity of voles and b) Crack at the test dike

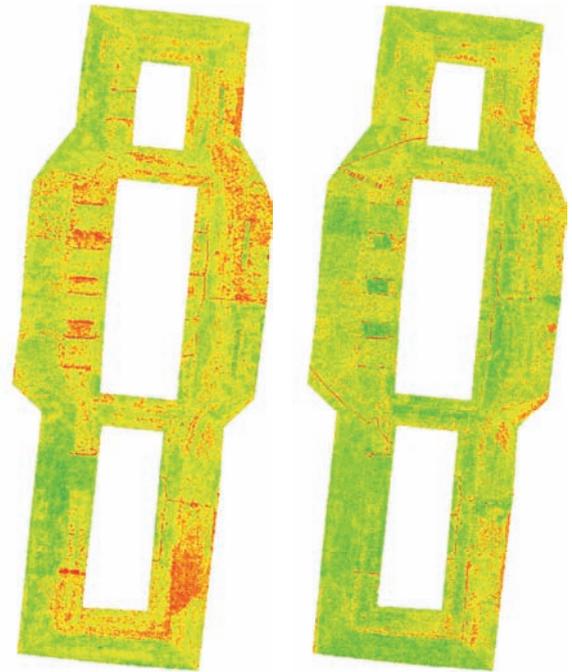
Fig 22. Comparison of cover ratio of the test dike after winter season in April (left) and mid June (right) 2013 (basis aerial photo Professorship of Geodesy and Geoinformatics)

Through the classification the development status of the test dike in April and June could be compared. But it has to be said when comparing both images, that the lighting conditions as well as the mowing situation on the days the shots were made were not congruent.

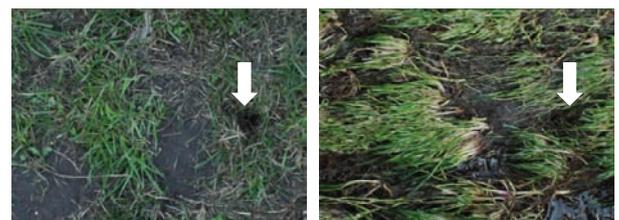
Fig 23. Detail cross section D, a) Initial situation (bare areas and vole hole) b) 4th overtopping

functional failure of the slope could not be detected. Single grass blades of the turf were pulled through high traction from the overflowing water. Apart from that, areas without vegetation cover were eroded. The highest concentration of roots shows the first third of a cover. The consequence of erosion is the reduction of the protective effect. In the areas with no vegetation cover the surface is exposed to hydrodynamic impacts and the erosion progresses in depth (Vavrina, 2010). The fine grained soil particles were eroded through overflowing water till the network of roots beneath lay open. Soil particles were partly washed out of the roots. If the highly branched root system of young fine elastic roots remains intact than it will resist till the highest loading increment so far. After the first overtopping almost only the bare areas were visible when the mowing rests and dry grass vanished. Fig 23a shows a vole hole surrounded by a nearly intact vegetation cover. The highest investigated loading increment so far with 4 overtopping events and a maximum flow velocity of 3.52 m/s (maximum water height 0.1 m) showed no grave damages at this point (Fig 23b).
