# DredgDikes

South Baltic Guideline for the  
Application of Dredged Materials,  
Coal Combustion Products and Geosynthetics  
in Dike Construction

## ANNEX II

South Baltic Guideline for the Application of Dredged Materials,  
Coal Combustion Products and Geosynthetics in Dike Construction, Annex II  
Rostock, 2015

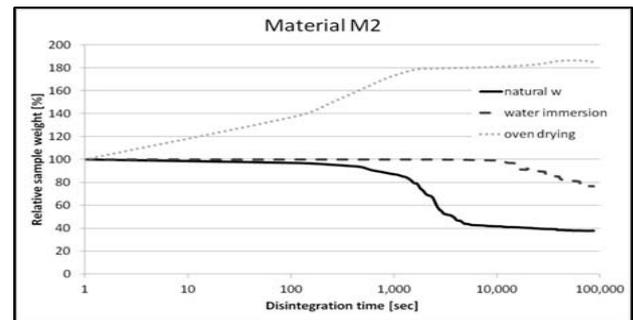
Figure AII.2. Disintegration curves from the Weißmann test

In the test after Weißmann [4], the disintegration time for a liquidity index of  $LI = 0.2$  is used to determine the erosion resistance. For each sample the disintegration time  $t_{30}$  (time to lose 30 % weight) is determined (with  $t_{30} = 24$  h if max. weight loss  $< 30$  %). The function  $t_{30,w} = f(w)$  is plotted for three test water contents (oven-dried,  $w_{opt}$  and wet). Weißmann proposed an exponential dependency of  $w$  and  $t_{30}$ . Since the method could not provide repeatable results for the DMs using  $w_{opt}$ , replacement samples were prepared with  $w_n$ . The results were different to those from the Endell test. The oven-dry samples showed an increase in weight instead of a loss, although soil crumbling was observed, while the wet samples started to crumble after  $\approx 3$  hrs. with a maximum weight reduction of less than 30 %. The  $w_n$  samples showed the largest weight reduction (Table AII.7). In none of the investigations a dependency between  $w$  and  $t_{30}$  could be determined; consequently,  $t_{30,w}$  at  $LI = 0.2$  could not be computed for any of the samples. Therefore,  $t_{30}$  for  $w_n$  was chosen for comparison, in spite of the large variation of  $w_n$  among the materials (Table AII.1).

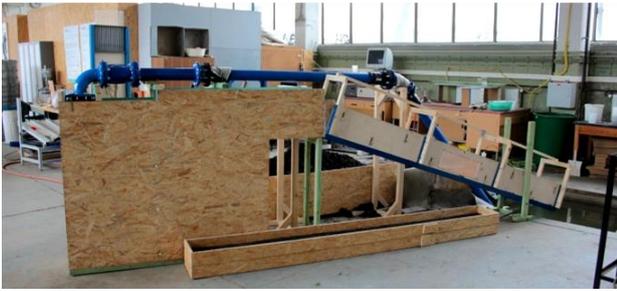
Figure All.3. Laboratory flume, sample boxes in the front

The basic structure of the construction consists of a turbulence tank and the actual flume. It has a width of 0.27 m and an effective length of 2.75 m with a variable slope. The water delivery system includes a basin, a pump, a pipe and the turbulence tank (Figure All.3, Figure All.4). The discharge can be regulated with a pipe valve. The maximum possible discharge is about 95 m<sup>3</sup>h<sup>-1</sup> resp. 380 m<sup>3</sup>h<sup>-1</sup>m<sup>-1</sup> (26 ls<sup>-1</sup> resp. 106 ls<sup>-1</sup>m<sup>-1</sup>). The flow conditions are usually supercritical.

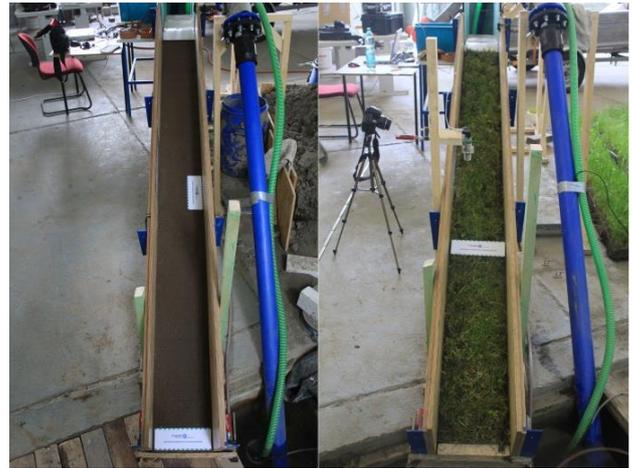
Figure All.5. Installed samples, unvegetated (l) and vegetated (r)

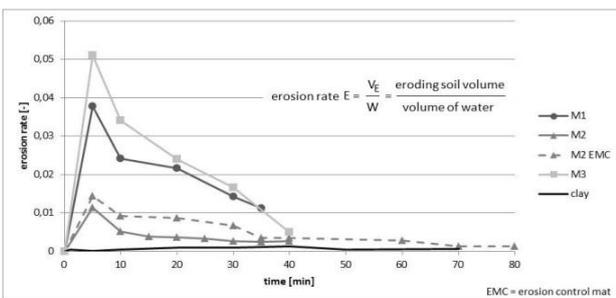
Figure AII.6. Erosion rates of dredged materials (M1-M3) and clay [23]

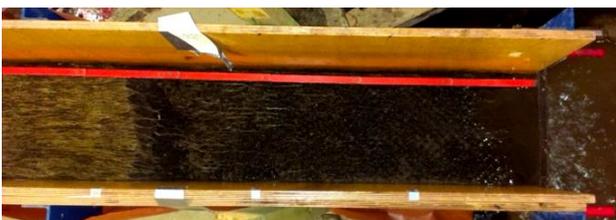
Figure AII.7. Downstream erosion above the geomat (GMA), originate at a crosswise crack (M2, December 2013)

The pin-profiler was used exclusively for vegetated samples. Due to the quite low pump performance no significant erosion was observed in almost non experiment. In the course of installation some cracks occurred crosswise in length direction. Only in these areas a significant amount of soil eroded downstream (Figure AII.7).

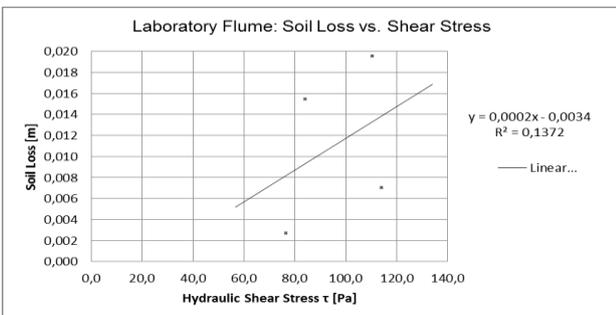
Figure AII.8. Cumulated soil loss vs. shear stress, single significant case of erosion from the lab tests, vegetated samples (M2, Dec. 2013)

Figure AII.8 shows the soil loss versus the hydraulic shear stress. The initial shear stress was between 60 Pa and 80 Pa and the mean maximum soil loss was  $CSL \approx 0.019$  m. The mean hydraulic parameters were  $\varnothing q \approx 64$  ls<sup>-1</sup>m<sup>-1</sup>,  $\varnothing v \approx 2.37$  ms<sup>-1</sup>,  $\varnothing \tau \approx 110$  Pa.

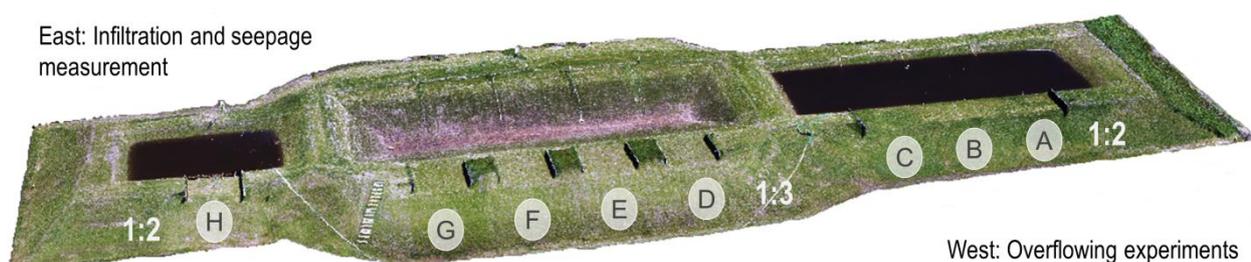
Figure AII.9. Rostock research dike, west view [24].

The large-scale research dike in Rostock consists of two parallel dikes (west and east) which are connected with earth dams to form a three-polder system (Figure AII.9). The polders can be filled with water separately for hydraulic loading. There are ten different dike cross-sections, all separated by mineral sealing material to prevent seepage water to spread between the sections. Most of the sections have been realised twice, on the eastern and the western dike respectively.

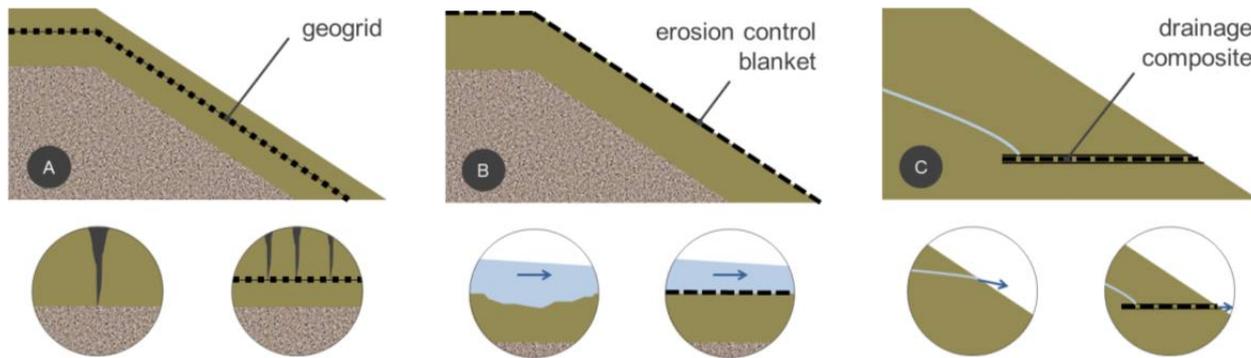
Figure All.10. Schematic cross-sections: A. Sand core & geogrid reinforced dredged material cover. Without geogrid large cracks. With geogrid more smaller cracks not exceeding the geogrid. B. Sand core & erosion protected dredged material cover. Without erosion control blanket - surface erosion due to overflowing. With erosion control no erosion is expected. C. Homogenous dike with geosynthetic drainage composite. Without composite seepage may occur on the inner slope. With composite defined drainage.

friction between soil and reinforcement material needs to be high even for very small displacements, a geosynthetic erosion control grid (Huesker Fortrac 3D) was used. Without reinforcement large cracks were expected that may reach the sand core. With reinforcement installed, a larger number of smaller cracks were expected, not exceeding the reinforcement (Figure AII.10A).

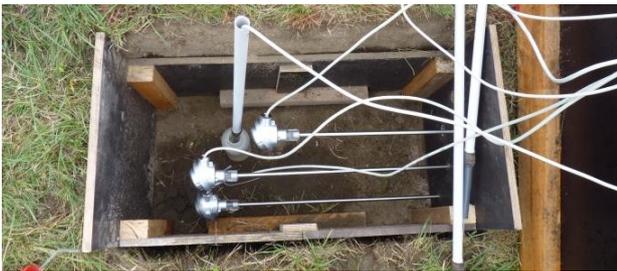
Figure All.19. TDR-sensors and tensiometers under the flumes

In addition, the moisture content and the water saturation of the top layer material was determined with TDR-sensors and tensiometers in a depth of 10, 20 and 30 cm below the outer two flumes (Figure All.19).

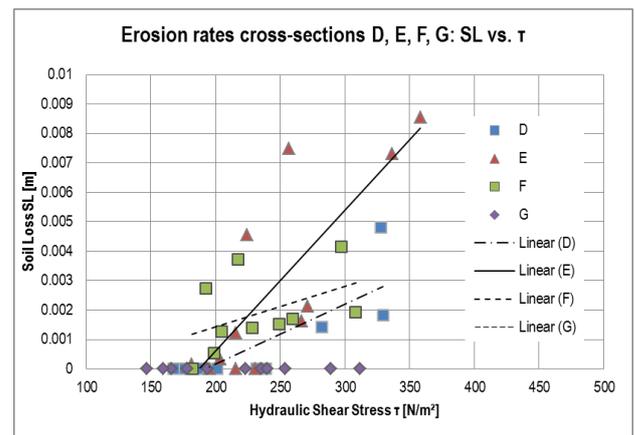
Figure AII.20. Erosion rates in cross-sections D, E, F, G Sept. 2013; the steeper the trend line the higher the erosion rate.

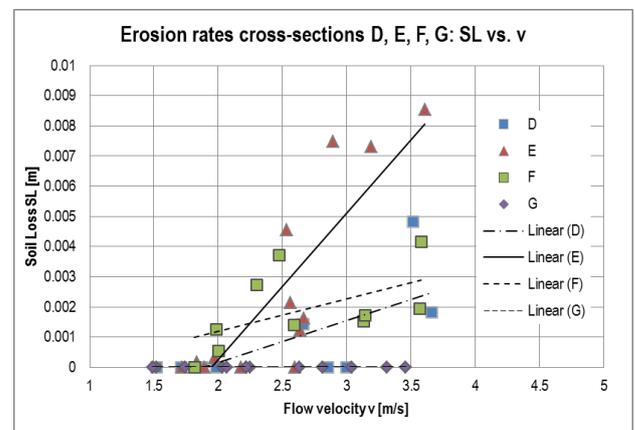
Figure AII.21. Erosion rates in cross-sections D, E, F, G, Sept. 2013; the steeper the trend line the higher the erosion rate.

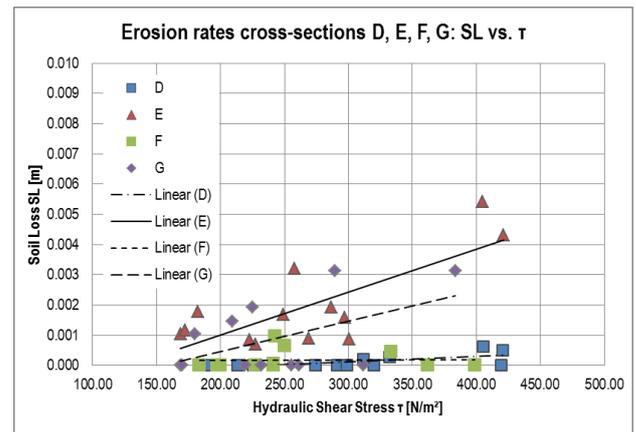
Figure AII.22. Erosion rates in cross-sections D, E, F, G May 2014; the steeper the trend line the higher the erosion rate.

The experiments which were carried out in May 2014 showed comparable results regarding initial shear stress and flow velocity. The soil loss starts at lower values of the hydraulic parameters ( $\tau \approx 170$  Pa,  $v \approx 1.8$  ms<sup>-1</sup>), but the total amount of cumulated soil loss is also lower (Figure AII.22 and Figure AII.23).

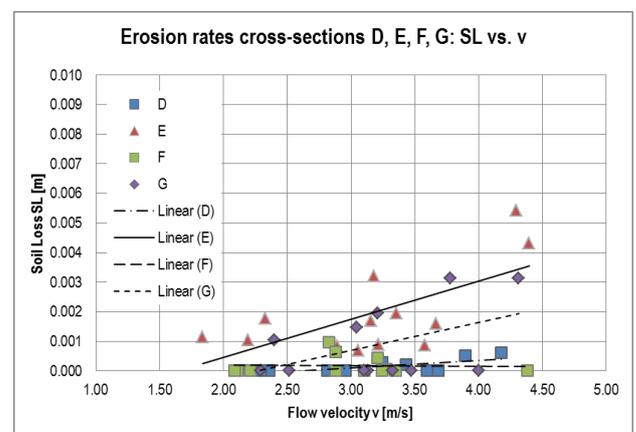
Figure AII.23. Erosion rates in cross-sections D, E, F, G May 2014; the steeper the trend line the higher the erosion rate.

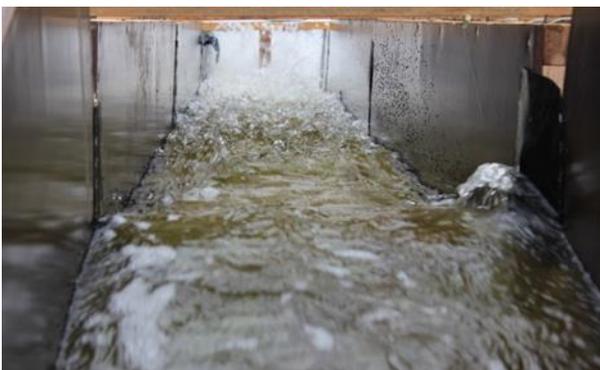
Figure All.25. Turbulent flow conditions in with air entrainment in the lower parts of the flume

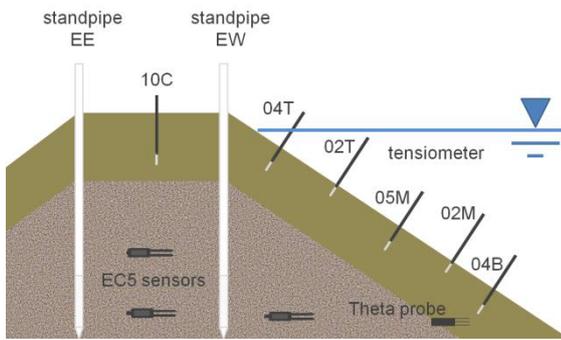
Figure All.26. Schematic view of an instrumented cross-section.

The standpipes were installed both on the eastern and the western dike for comparison. Only the western standpipes on the eastern (seepage) dike (EW in Figure All.26) that are near to the outer slope are equipped with an electronic piezometer to log the seepage water table while on side the water level inside the other standpipes

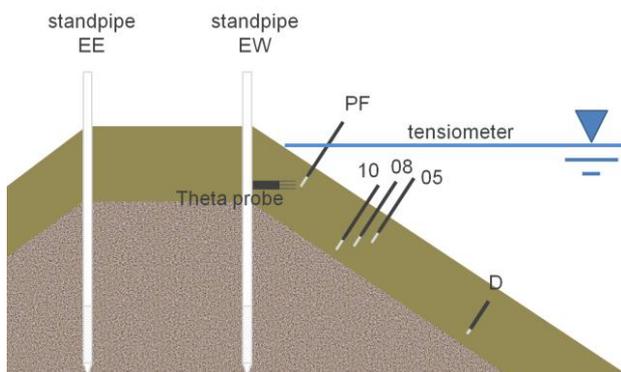
Figure AII.34 Redesigned measurement set up 2014.

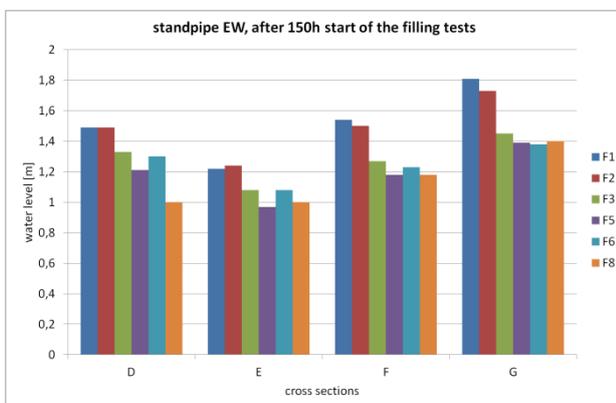
Figure AII.38. Standpipe EW, after 150 h, filling test, polder 2

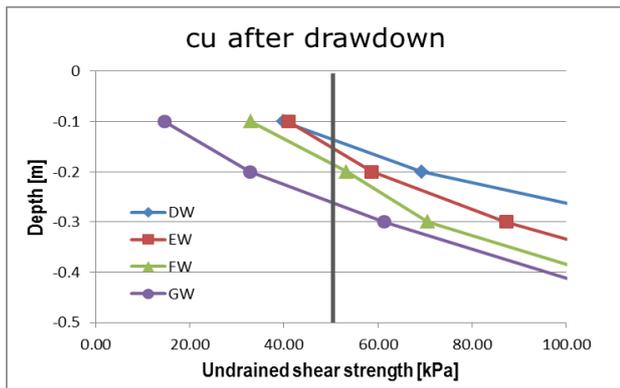
Figure All.42. Field vane shear test, *cu* after drawdown, polder 2

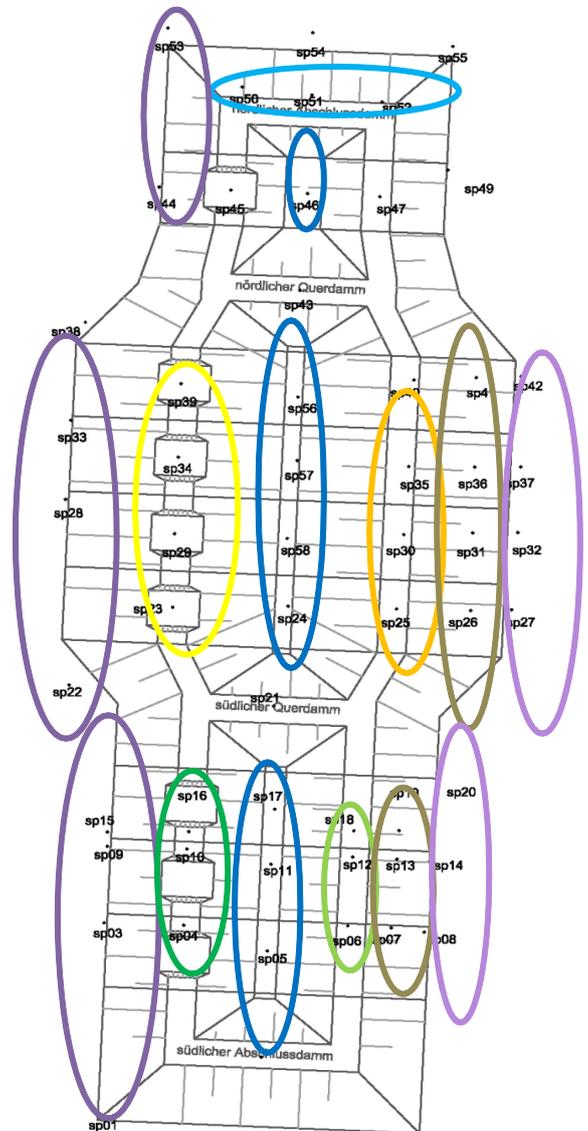
Figure All.43. Results of the geodetic settlement measurements

Since the initial measurement on 06 June 2012 five control measurements were performed until 27 June 2013. Settlements of up to  $s = 0.2$  m at the crest and usually  $s < 0.1$  m at the toe were measured. A selection of results is provided in (Figure All.43).

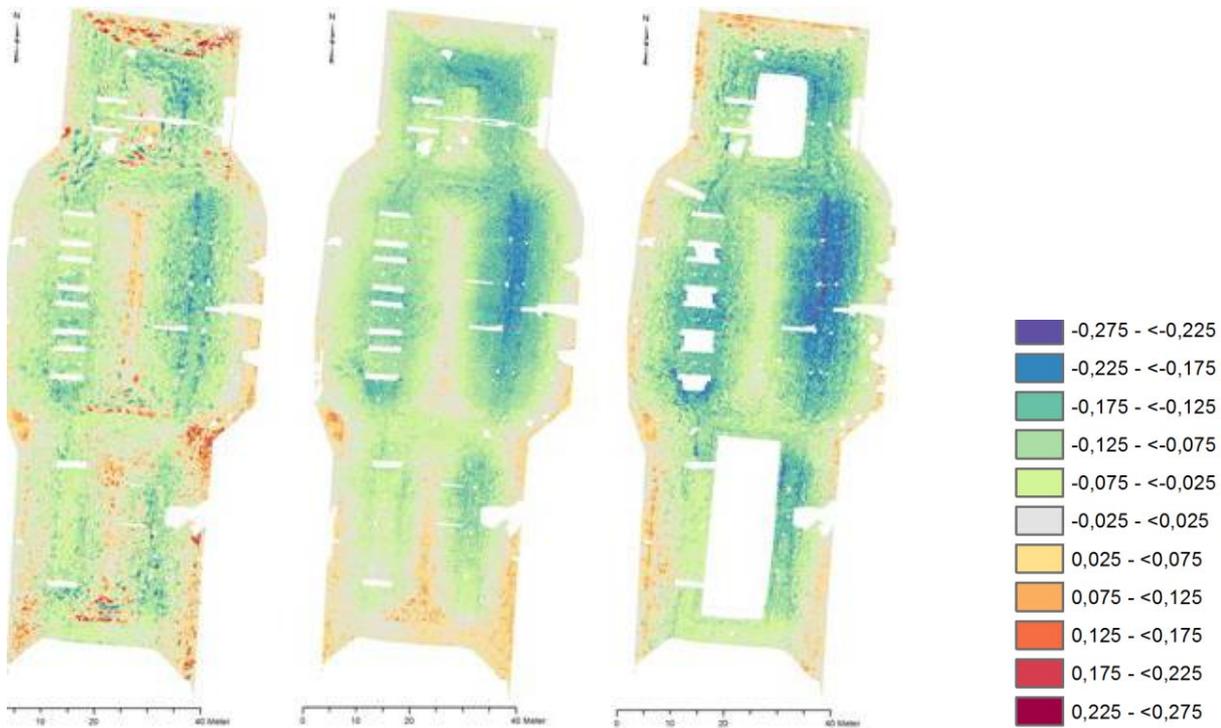
Figure All.44. UAS (unmanned aerial system) photogrammetric measurements of the Rostock research dike – deformations

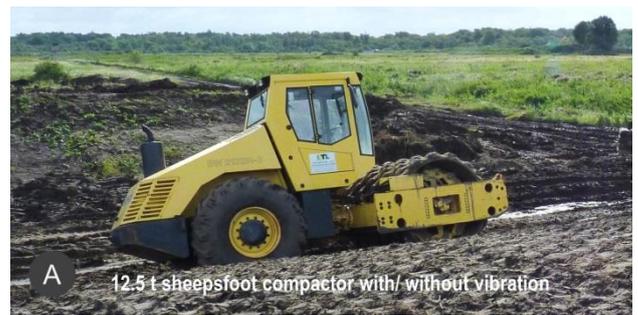
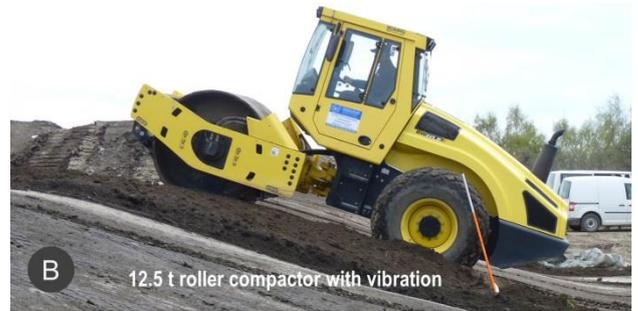
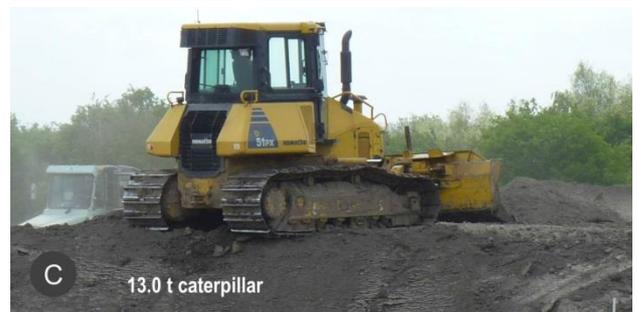
Figure AII.47. Compactors used for the technology comparison

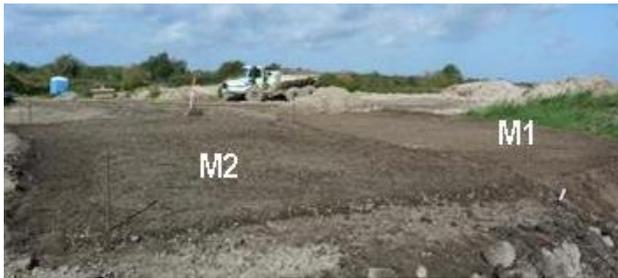
Figure All.51. Prepared compaction testing field

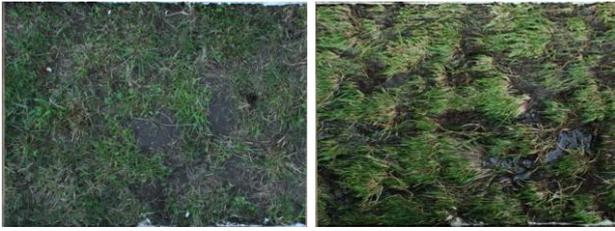
Figure All.54. Cross section D (52 x 38 cm), flume 1, section 6, initial situation (l) and after the fourth test (r)

The problem of comparing the different sections is to estimate the damages of the initial situation and after overflowing events (Figure All.54 and Figure All.55). A digitalization that will enable the estimation of damages is always a subjective procedure because there are no clearly visible edges. There are also problems with the mowing residues at the beginning and the bending grass due to the flowing water, partly covering damages.

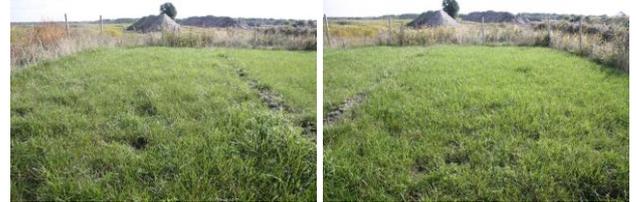
Figure All.56. Turf in September 2013 of the compaction testing fields materials M1 (l) and M2 (r)

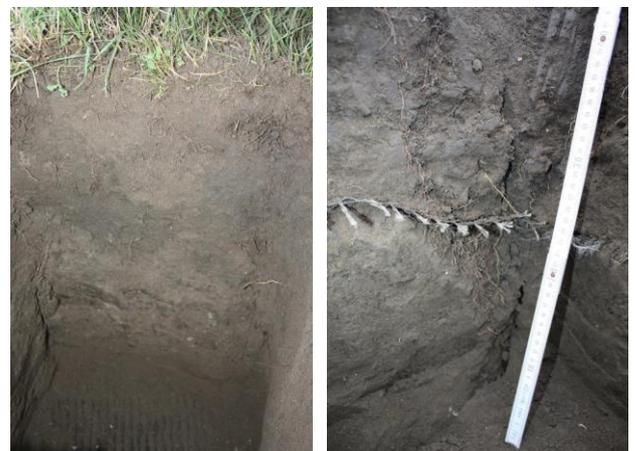
Figure All.59. Material M1 soil horizon depth 60 cm (3D-RM) (l), Material M2 3D-RM in 30 cm depth (visible rooting and cracking) (r)

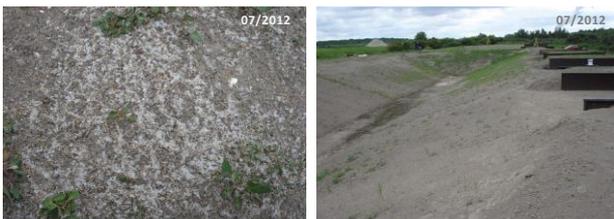
Figure All.60. Surface of test dike two weeks after hydro-seeding; decomposed binder (l), beginning saltbush growth (r)

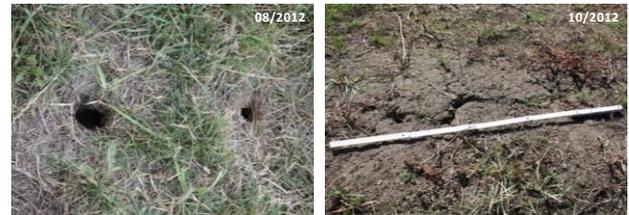
Figure All.62. Activity of voles (l) and crack on the research dike (r)

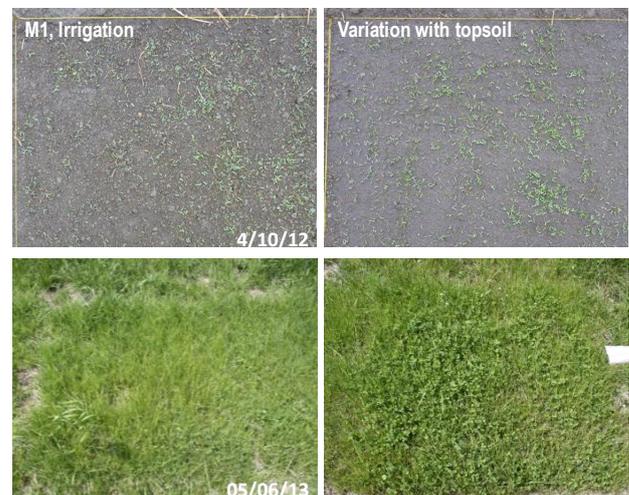
Figure All.63. Two different variations of the seeding test on the dike embankment – compacted surface, M1 with initial irrigation (l) and variation with topsoil (2 cm) above M2 (r)

The test fields were installed in mid-Sept. 2012 resulting in a fast and regular greening. Only marginal differences between the variations could be observed: the vegetation cover in the variations with standard topsoil germinated 1-2 days earlier and looked a bit more compact initially. The fields were monitored through 2013. The differences in compactness levelled quickly and only the amount of legumes stayed higher in the topsoil variation (Figure All.63).

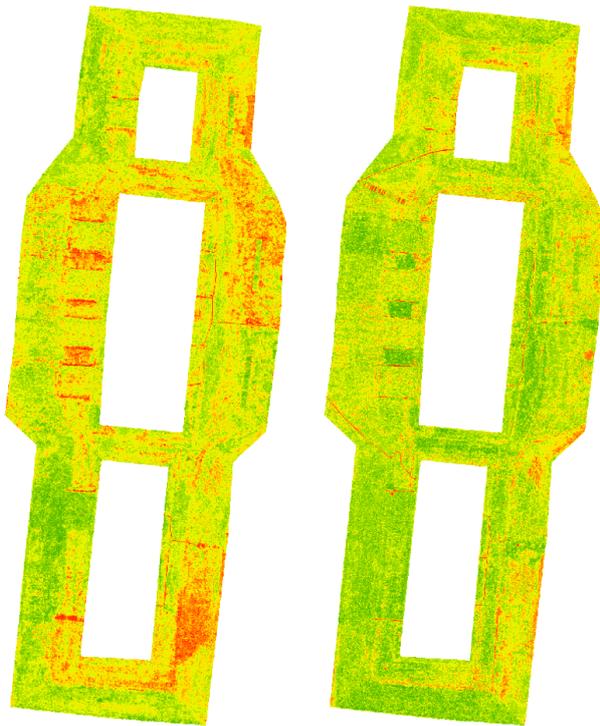
Figure All.64. Comparison of cover ratio of the test dike after winter season in April (l) and mid-June (r) 2013 (aerial images from [42])

The whole vegetation cover of the research dike was checked twice using aerial images (cf. above). The cover ratio and vitality were estimated and compared. In April 2013 after the winter up to 64 % of the areas were covered with vegetation in a good state. In June 2013 with recovered vegetation 80 % of the areas achieved a good cover ratio. Some areas were still not completely covered until June, so e.g. the eastern slope of polder 1. This slope had little vegetation from the seeding and was covered very fast by the saltbush (*Atriplex*). In winter the saltbush died back. Despite of re-sowing some areas were still bare in June (Figure All.64).

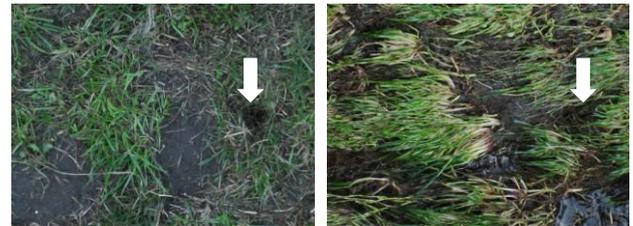
Figure All.65. Detail cross-section D; Initial situation (bare areas and vole hole)(l), state after fourth overflowing (r)

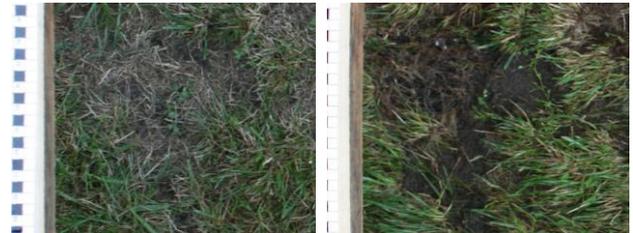
Figure All.66. Detail E (initial situation with dry vegetation) (l), fourth overflowing (fine networking roots visible in RECP) (r)

Figure All.66r shows very pronounced surface erosion in cross section E, on the erosion control geomat GMA. The turf was damaged before the experiments started,

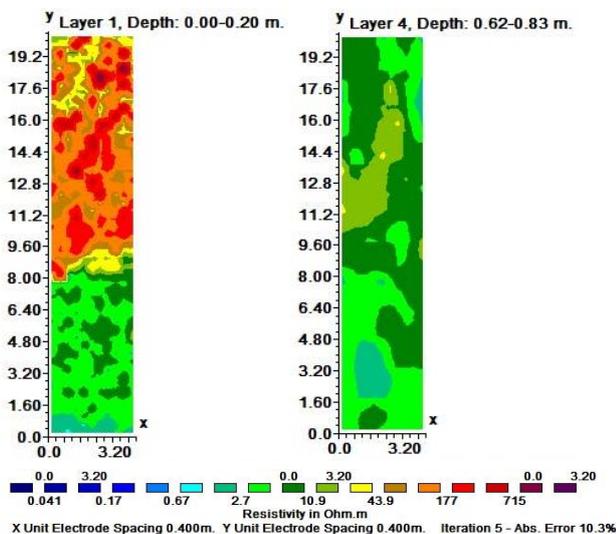
Figure All.67. ERT evaluation Sept. 2014 [43] for cross-section D, measured 4 m wide strip across the section; 0 = outer embankment toe (inside polder); diagram of horizontal layers 1 & 4 of 8.

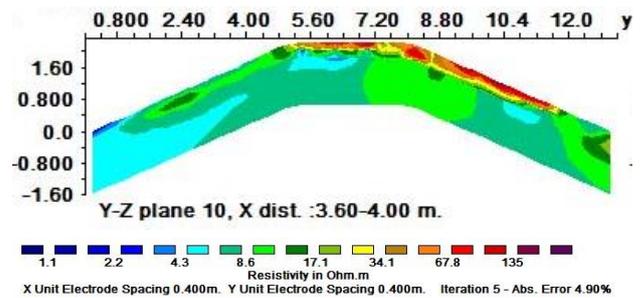
Figure All.69. ERT evaluation Sept. 2014 [43] for cross-section H, measured 4 m wide strip across the section; 0 = outer embankment toe (inside polder); diagram of vertical cross-section 10 of 11.

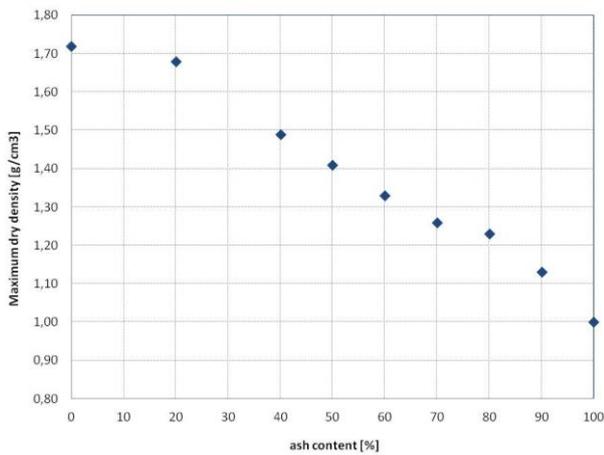
Figure AII.72. Maximum dry density for the different composites

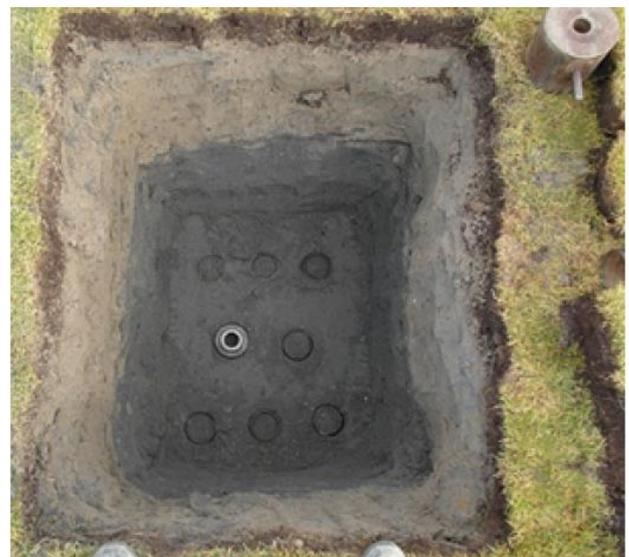
Figure All.79. Obtaining undisturbed samples of bottom ash-dredged sand mixture from the excavation at the test dike in Gdańsk.

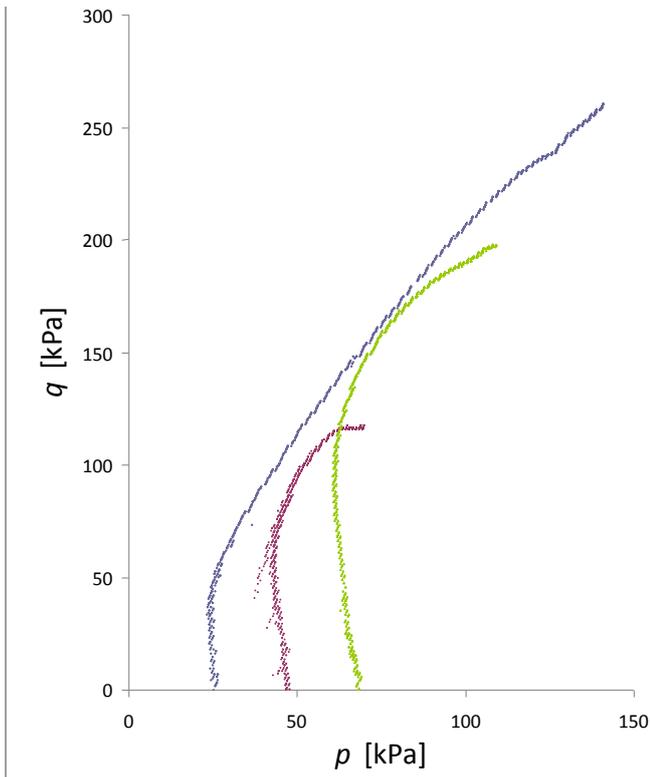
Figure All.80. Example results of undrained triaxial tests on undisturbed samples of DMs from Rostock harbour (stress paths on  $p$ - $q$  plane).

In the case of less permeable and cohesive DMs from harbour undrained triaxial tests should be performed. Example results are shown in Figure All.80. It allows to determine effective and undrained strength parameters (effective friction angle  $\phi'$ , effective cohesion  $c'$  and undrained cohesion  $c_u$  respectively). The effective stiffness parameters should be obtained from other tests, preferably oedometric compression.

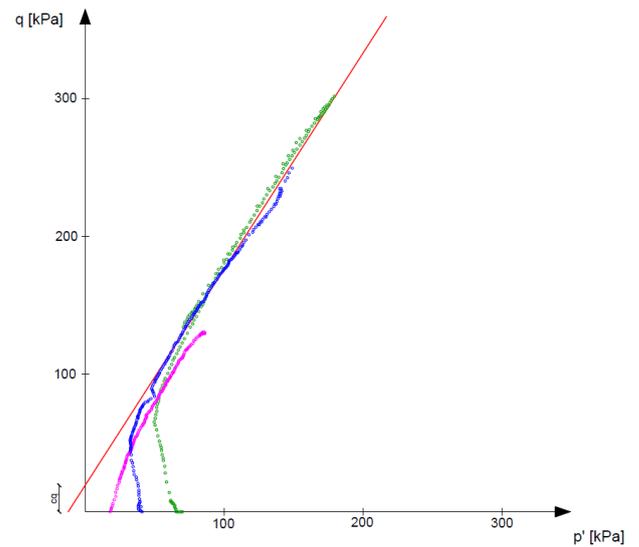
Figure All.81. Example results of undrained triaxial tests on undisturbed samples of bottom ash-dredged sand mixture (stress paths on  $p$ - $q$  plane).

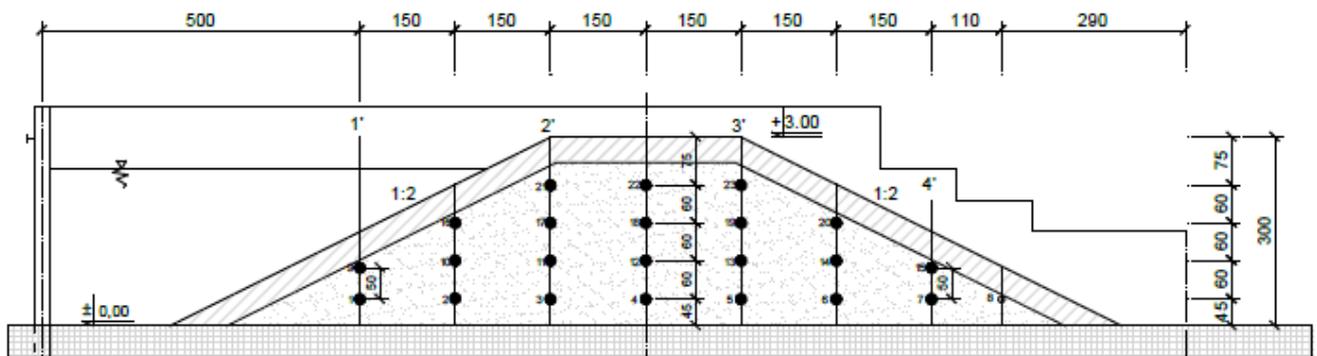
Figure All.83. Geometry of the Polish research dike section and position of moisture probes and piezometers

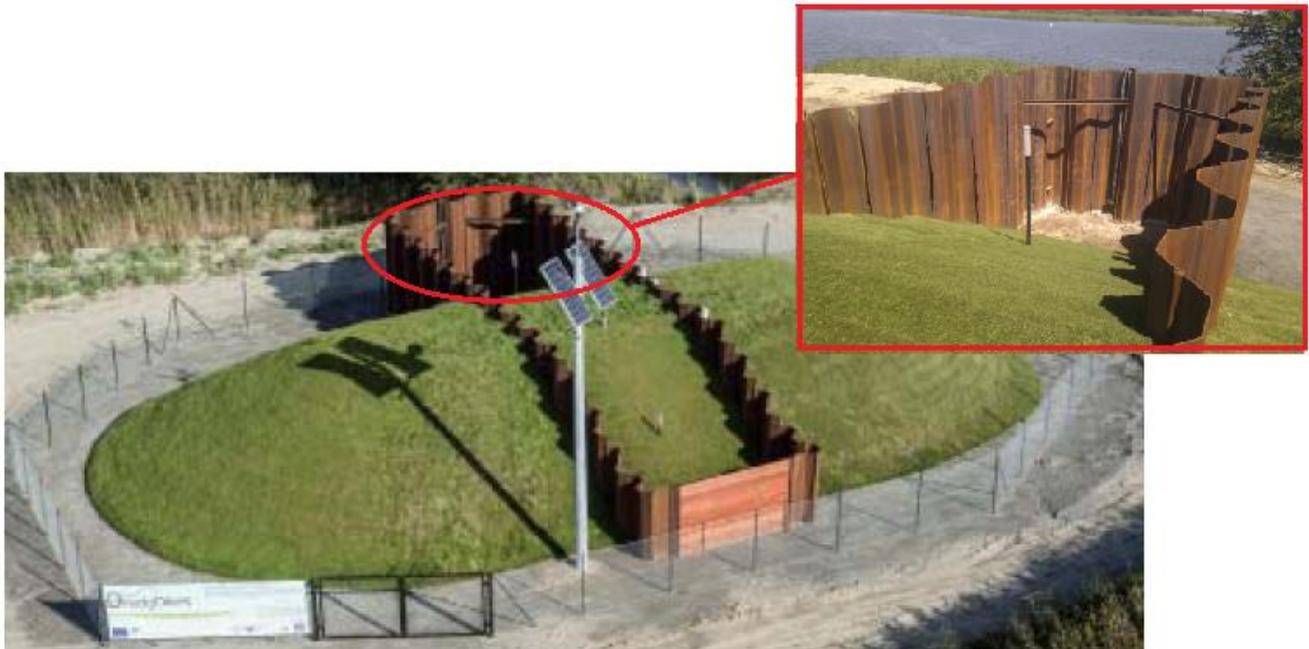
Figure All.84. Polish research dike with sheet pile basin

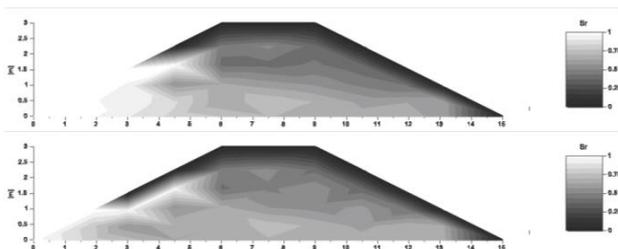
Figure AII.87. Maps of  $S_r$  at  $t=1h$ ; experiment: No.1 (upper graph) and No.2 (lower graph)

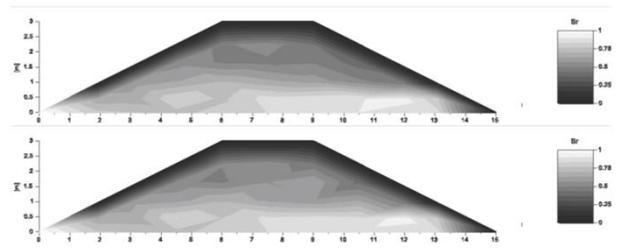
Figure AII.91. Maps of residual  $S_r$  at  $t=96h$  after water release in experiment: No.1 (upper graph) and No.2 (lower graph)

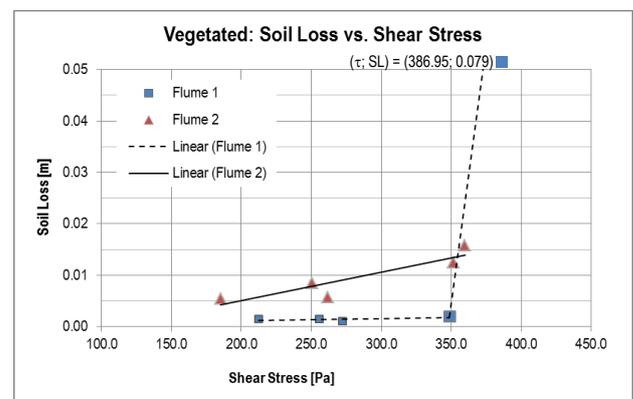
Figure AII.99. Erosion rates flumes 1 & 2 (vegetated); soil loss and shear stress, steep trend line = high erosion rate, Sept. 2014

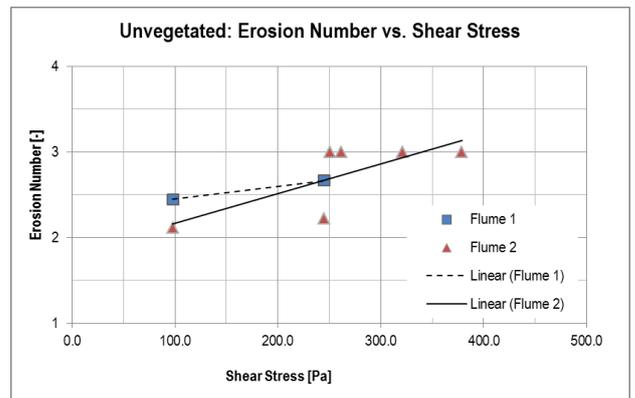
Figure All.106. Erosion rates flumes 1 and 2 (unvegetated); Erosion number (grade) and shear stress, steep trend line = high erosion rate

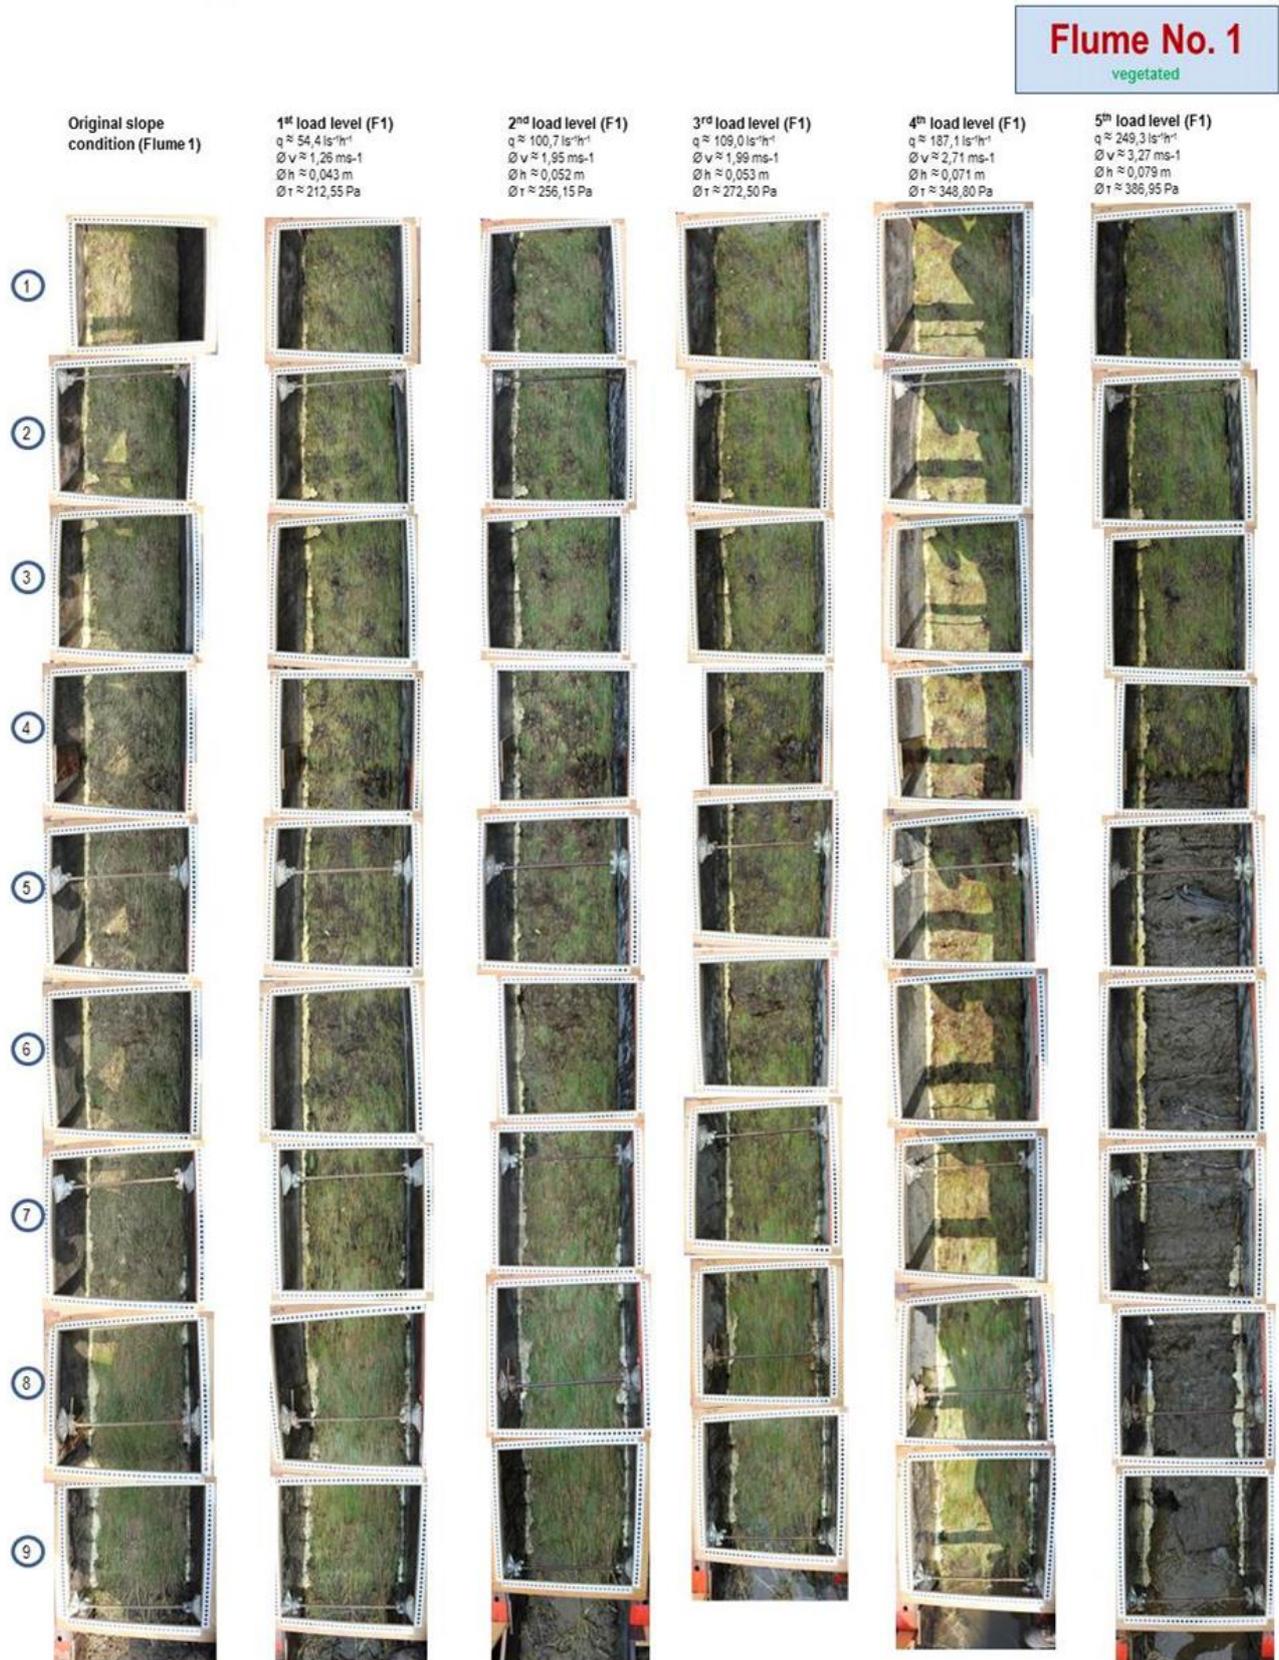
Figure AII.107. Development of the slope surface condition of flume no. 1. From left to right: initial state, after 1<sup>st</sup> target discharge, after 2<sup>nd</sup> target discharge, after 3<sup>rd</sup> target discharge, after 4<sup>th</sup> target discharge, after 5<sup>th</sup> target discharge. From toe to the crest: flow direction / numbered test sections.

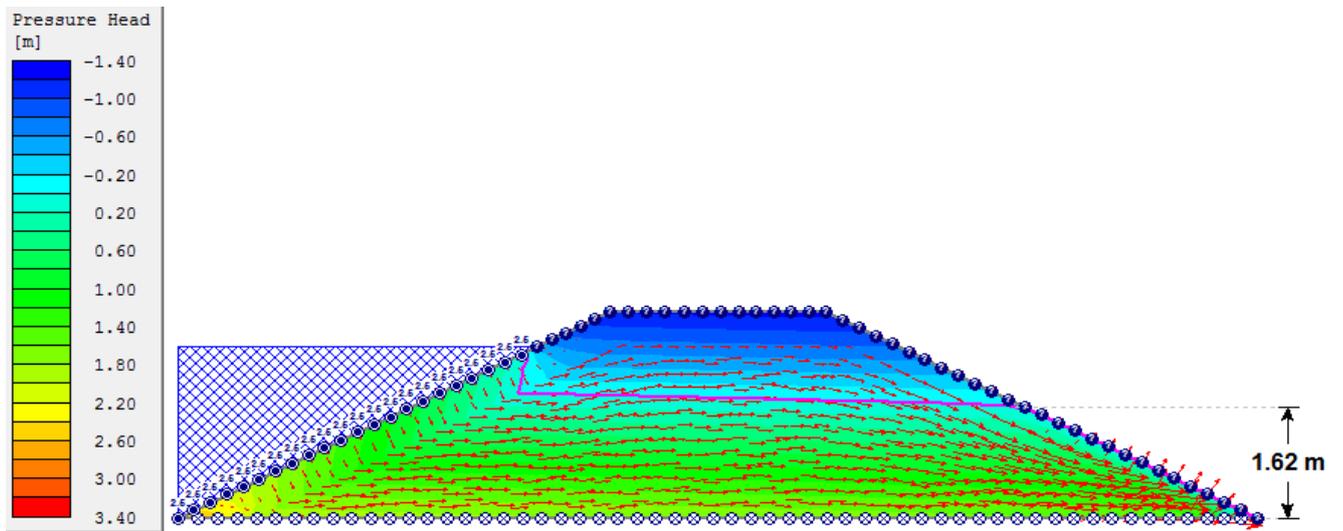
Figure All.111. Groundwater analysis. Slope 1:2

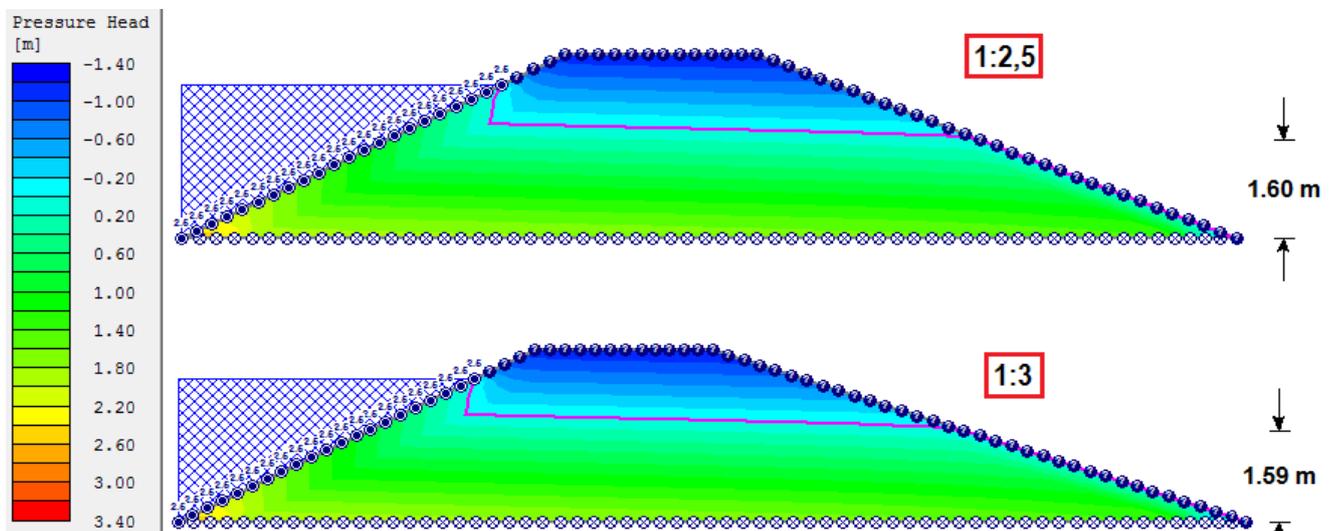
Figure All.112. Groundwater analysis. Slopes 1:2.5 and 1:3

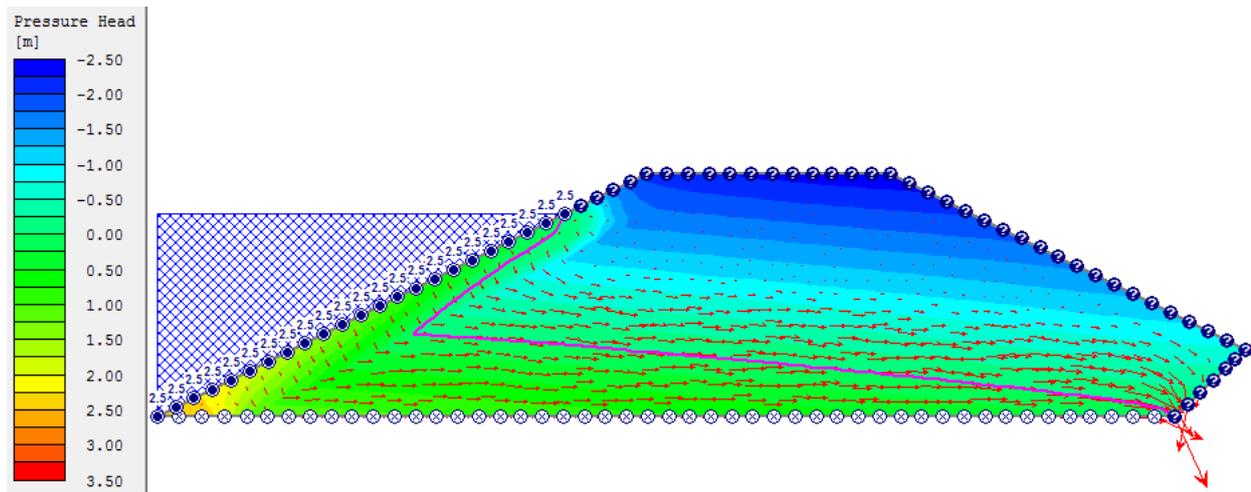
Figure All.113. Groundwater analysis with toe-drain

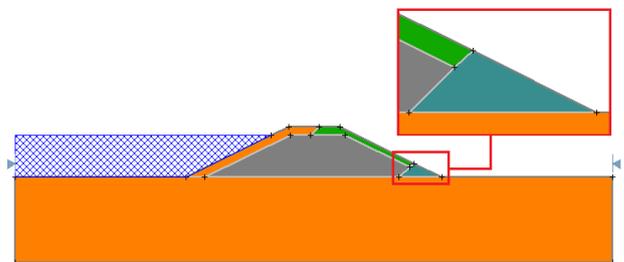
Figure All.114. Toe-drain in the embankment

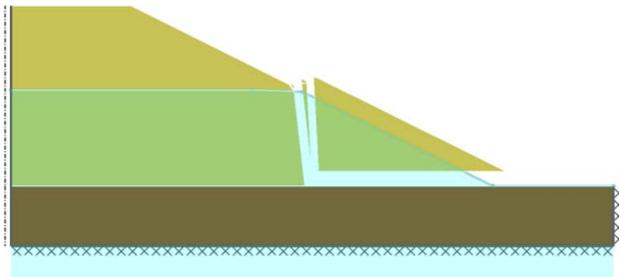
Figure All.116. Strength adequacy factor  $F$ , 1V:2H,  $c' = 5$  kPa,  $F = 0.692$  (unstable)

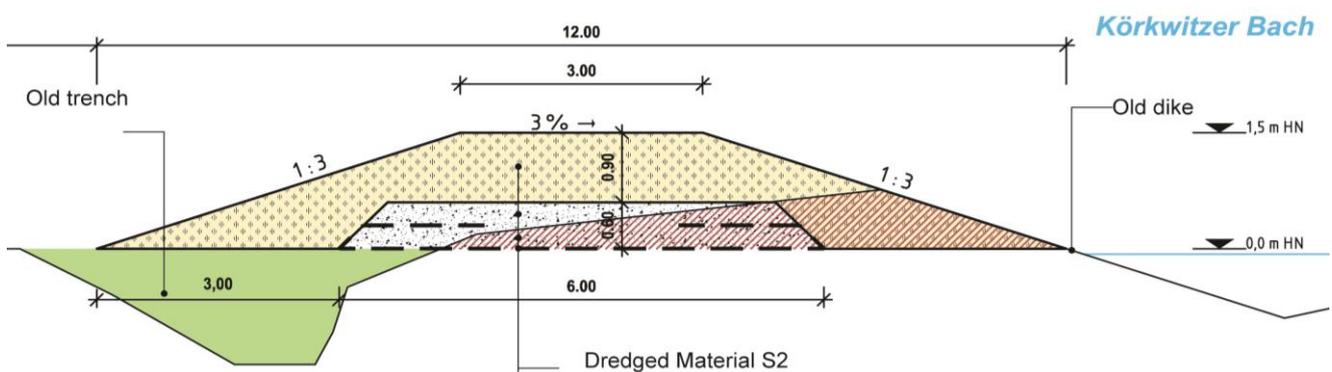
Figure AII.125. Standard cross-section for the reconstruction of the dike at the Körkwitzer Bach (WastraPlan 2013)

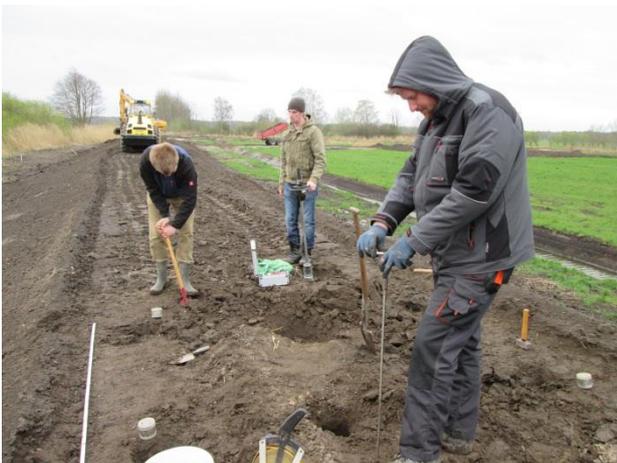
Figure All.129. Compaction control in the cover layer made of dredged material 04-2014

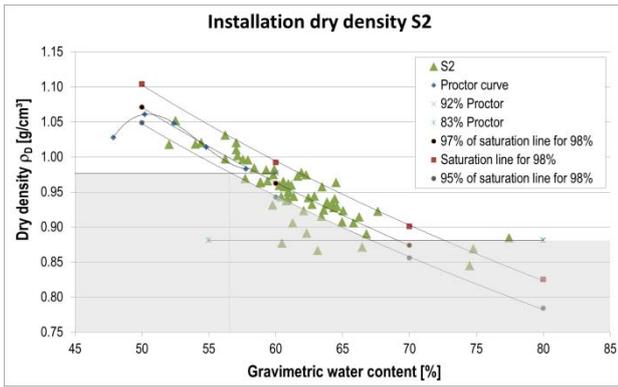
Figure All.130. Installation dry density of material S2 on the pilot dike compared with the proposed quality control method from the guideline

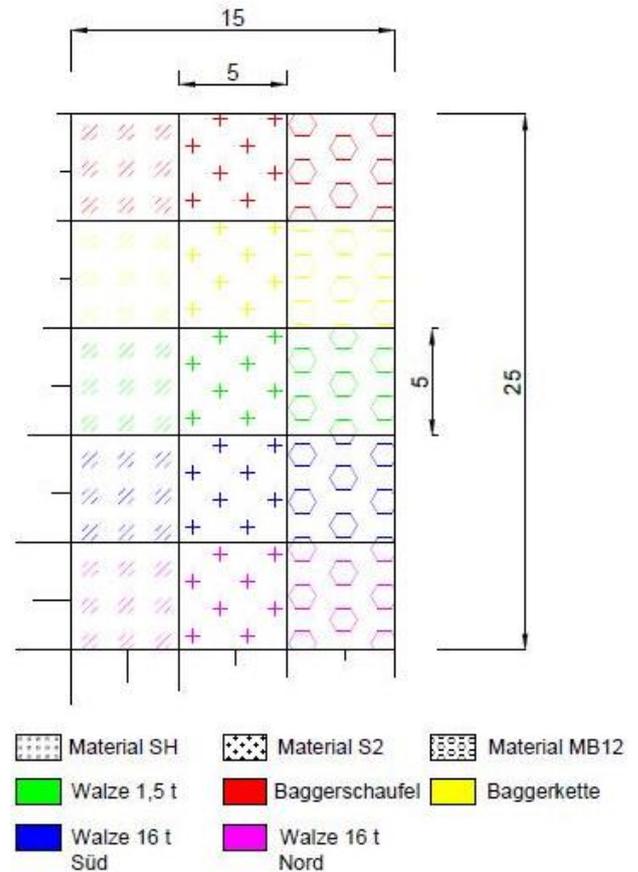
Figure All.134. Plan of the installation testing field 2014

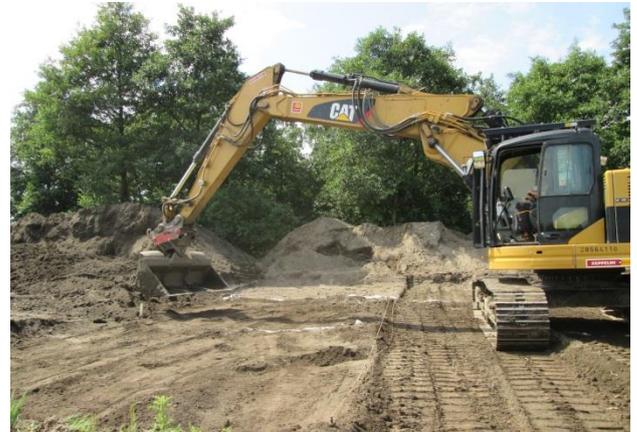
Figure All.135. Compaction with the excavator shovel only

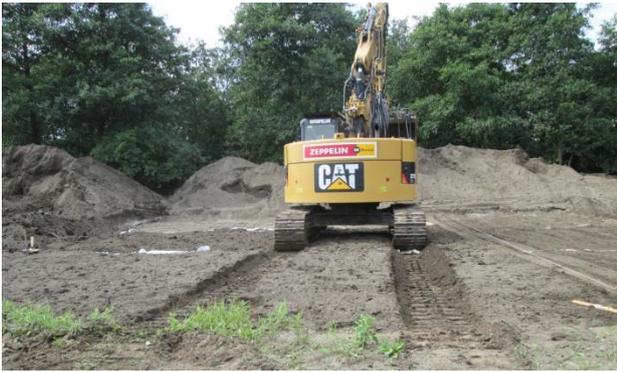
Figure All.136. Compaction with the excavator tracks only
