# DredgDikes

South Baltic Guideline for the  
Application of Dredged Materials,  
Coal Combustion Products and Geosynthetics  
in Dike Construction

## ANNEX II

South Baltic Guideline for the Application of Dredged Materials,  
Coal Combustion Products and Geosynthetics in Dike Construction, Annex II  
Rostock, 2015

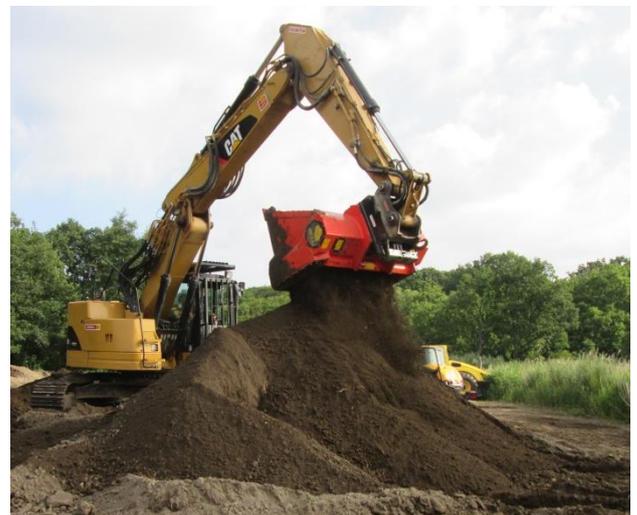
Figure All.139. Soil homogenisation with screener crusher

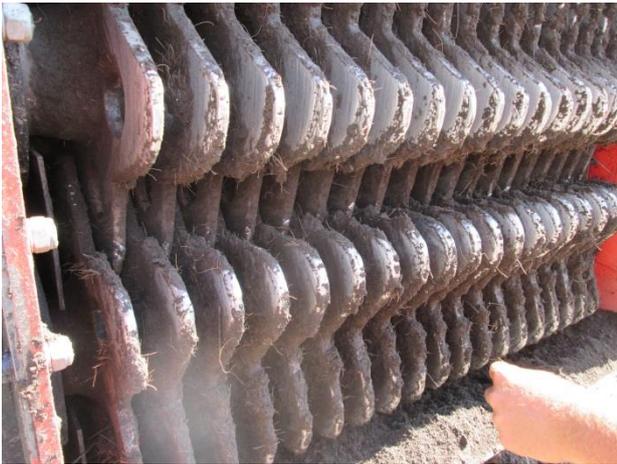
Figure All.140. Drums of the screener bucket for fine screening

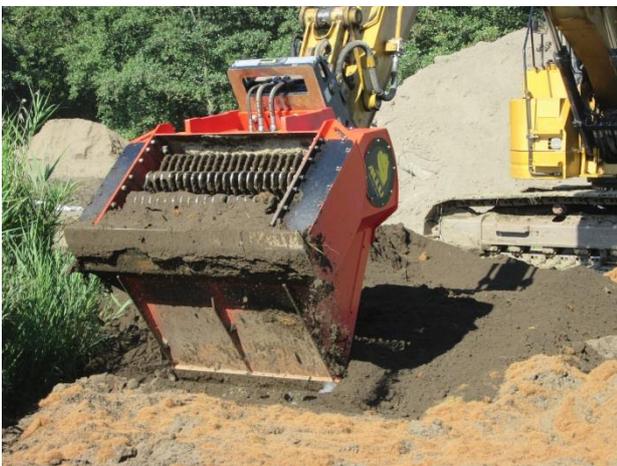
Figure All.141. Mixing of fibres and DM with the screener bucket

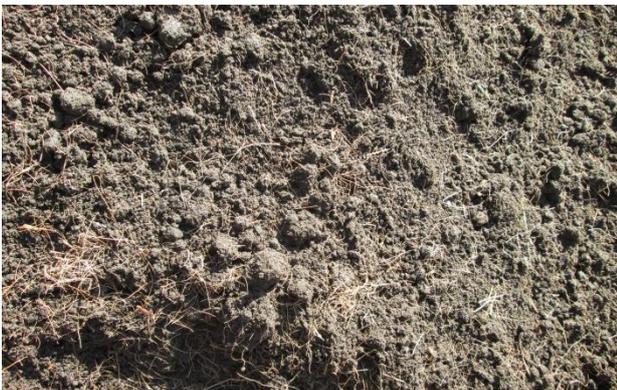
Figure All.142. Good fibre distribution in the DM

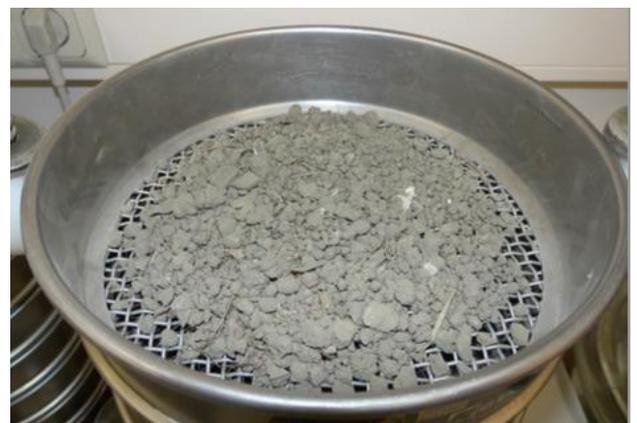
Figure All.143. Dried fibre and soil mixture during sieving

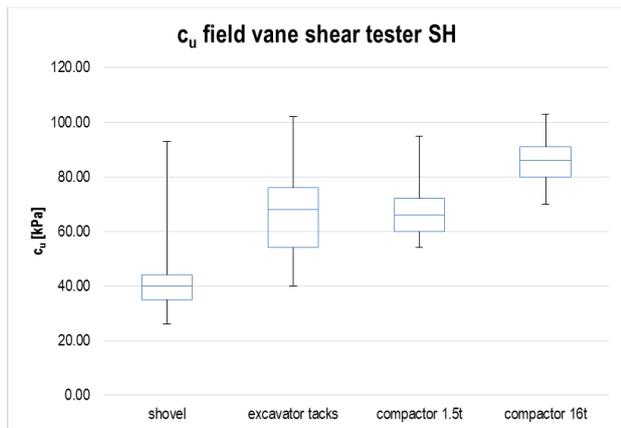
Figure All.144. Shear strength of material SH determined with a vane shear tester (median, 1<sup>st</sup> and 3<sup>rd</sup> quartile, min and max)

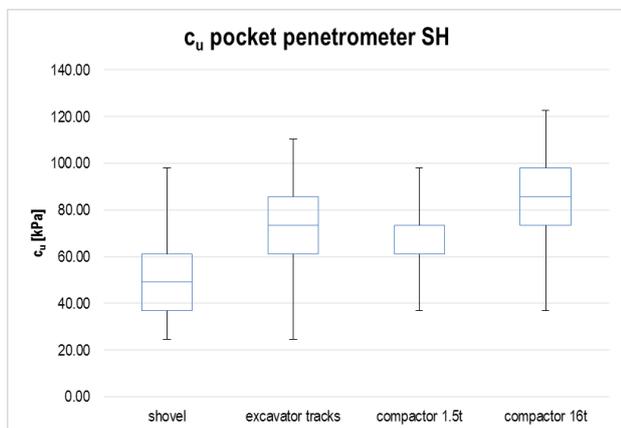
Figure All.145. Shear strength of material SH determined with a pocket penetrometer (median, 1<sup>st</sup> and 3<sup>rd</sup> quartile, min and max)

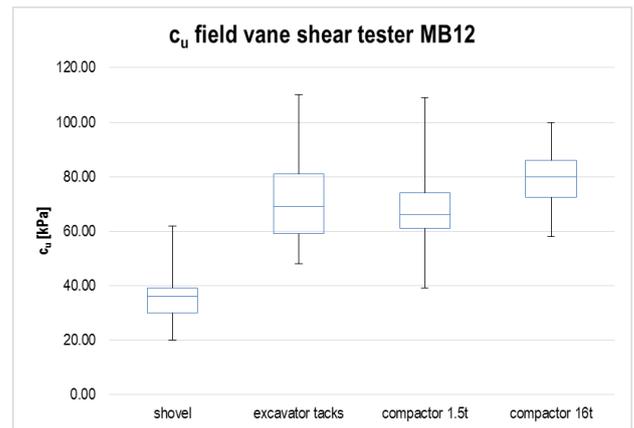
Figure All.146. Shear strength of material MB12 determined with a vane shear tester (median, 1<sup>st</sup> and 3<sup>rd</sup> quartile, min and max)

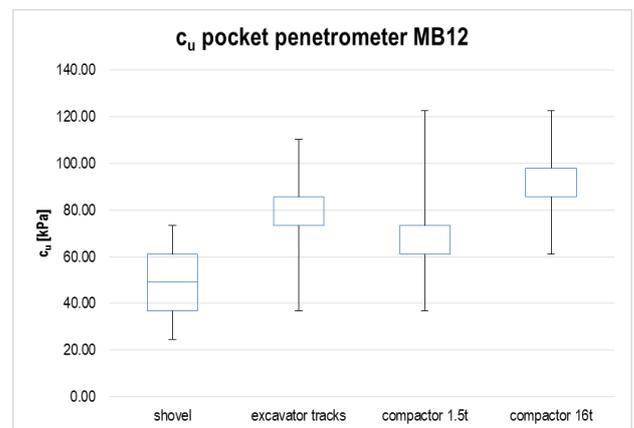
Figure All.147. Shear strength of material MB12 determined with a pocket penetrometer (median, 1<sup>st</sup> and 3<sup>rd</sup> quartile, min and max)

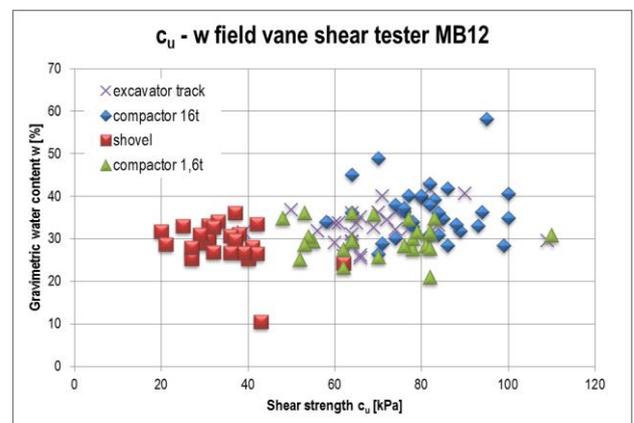
Figure All.148. Shear strength and water content for material MB12
