October 2014

Dredged Materials in Dike Construction

Implementation in the South Baltic Region using Geosynthetics and Soil Improvement

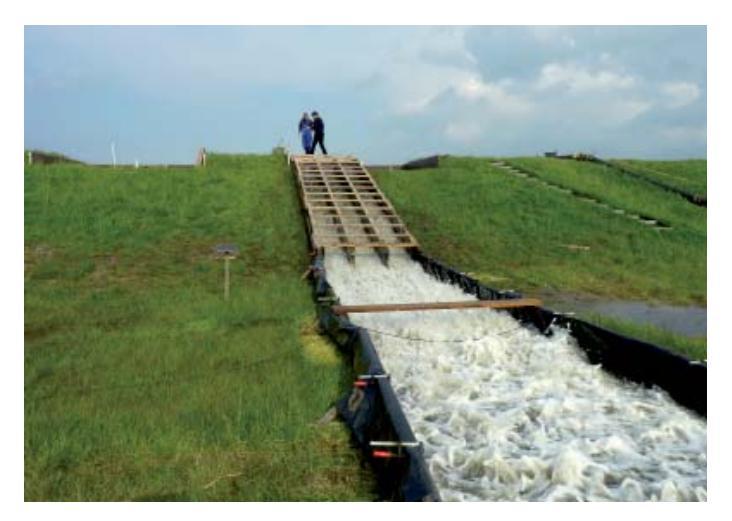
Fig. 1: Overflowing experiments Rostock, May 2014

For the 2014 overflowing tests on the *Rostock* research dike overflowing events of up to 600 l/s/m were simulated. For the overflowing experiments, the three parallel flumes were installed on the slopes again. They were fed by water overflowing the lowered sections on the western dike.

The tests confirmed the results from September 2013: Again, all slopes withstood the maximum overflowing rate of 600 l/s/m with a maximum flow velocity of 5.5 m/s. The results were obtained in stage tests in which different discharge volumes were applied for 45 minutes each. Between the stages the potential erosion was measured. Also, 24h long-term tests were performed which did not result in any erosion.

Poles were installed in the flumes and the vegetation cover was removed on an area of 0.3x0.9 m² to accelerate erosion. However, the slopes stayed intact due to a very good grass cover developed on the dreded materials.

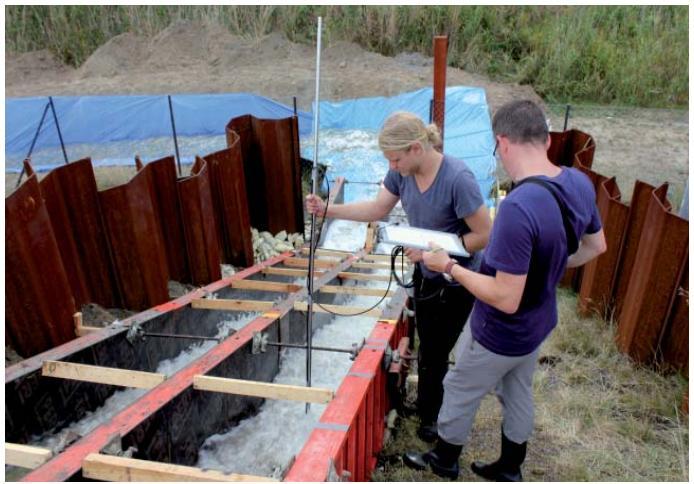
Fig. 2: Overflowing experiments Gdansk, September 2014

In September 2014 an overflowing test was performed on the *Gdansk* research dike. Again, the 60cm flume system was used. The maximum specific discharge was 400 l/s/m. The experiments showed that the grass cover, which was applied using pre-vegetated grass sods placed on top of the

clay and Tefra slopes, had not clung into the subsoil sufficiently. Thus, during a discharge of more than 200 l/s/m the top soil and vegetation was destroyed.

The bare clay cover showed erosion after a discharge of 50 l/s/m for 10 minutes, while the sand ash mixture performed better, showing only little erosion after 40 minutes of overflowing with discharges up to 200 l/s/m. Thus, it can be assumed that after a destroyed grass cover, the sand ash composite would still be stable for some time, however, a good vegetation cover is generally more effective.

For a durable vegetation cover, however, a solution other than pre-vegetated grass sods will have to be used.

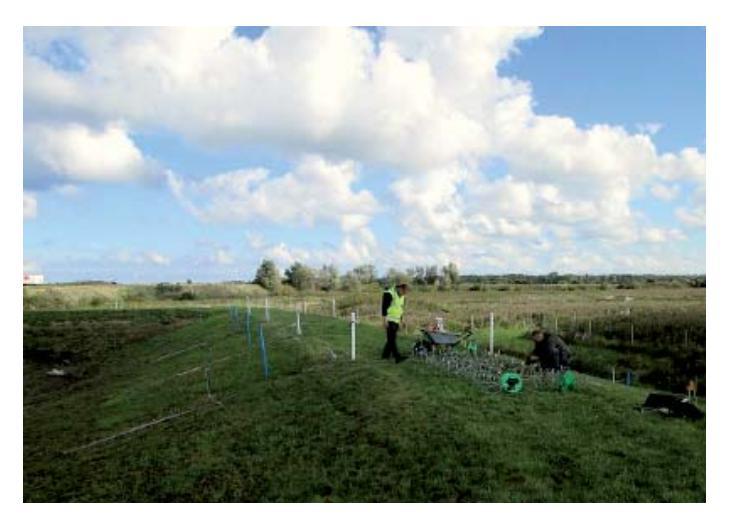
Fig. 3: ERT measurements on the Rostock research dike

During the first week of September 2014, Dr. Zielinsky, formerly researching geoelectric crack detection on embankments at the University of Strathclyde in Glasgow, Scotland, visited the *Rostock* research dike to perform his crack detection measurements. He used an electronic resistivity

tomography method with a dense electrode grid of 0.4x0.4 m². With this method sections D, E and H (materials M2 and M3, with and without geosynthetic reinforcement) were investigated to receive a 3D image of the electric resistivity inside the sections, thus allowing to visualise large dessication cracks and animal bore holes. Also, longitudinal 2D scans were performed on the crests of the dikes.

The results will be provided during the next months. They will be a great help in evaluating the seepage tests, which have been finished this September. Also, there may be information on the actual performance of the geogrid reinforcement.

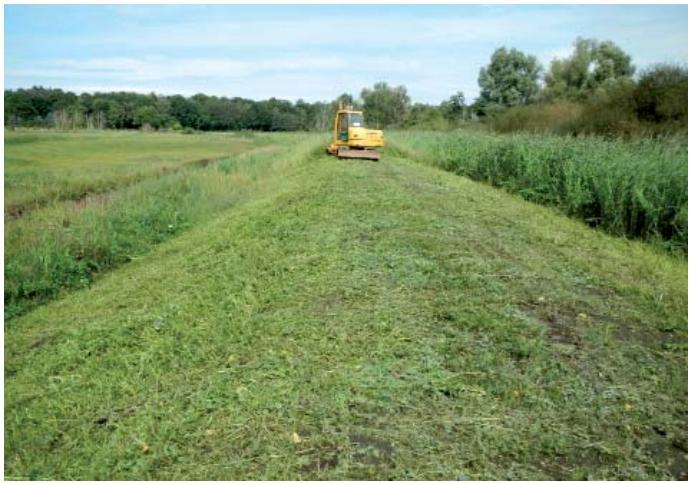
Fig. 4: Vegetation developed on the pilot dike

The pilot dike was instrumented with a small weather station, piezometers in the stream and dench on both sides of the dike as well as tensiometers and stand pipes on the dike (cover and core).

The vegetation has developed during the summer. Figure 4 shows the dike after the August grass cut.

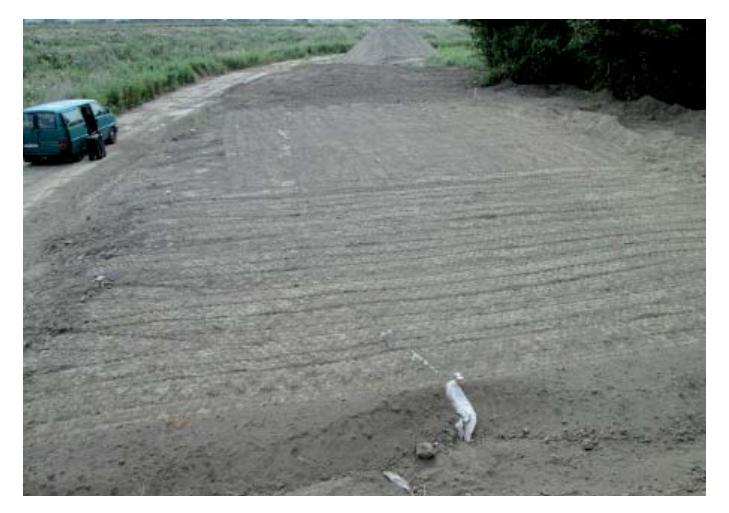
Fig. 5: Compaction testing field, August 2014

In the installation tests two different materials were installed (a fine-grained and a sandy dredged material). The materials were homogenised using a screening bucket fixed to an excavator. For comparison, also non-homogenised material was installed. Compaction was realised with the excavator shovel, the excavator tracks (replacement for the bulldozer), a small compactor and a large sheep's foot roller compactor.

Based on the experience from the research and pilot dikes regarding inhomogeneities of the dreged materials, the quality control using the degree of compaction is difficult. Particularly the high variation of local water contents in the installed materials are problematic. Therefore, an additional installation testing field was prepared in Rostock.

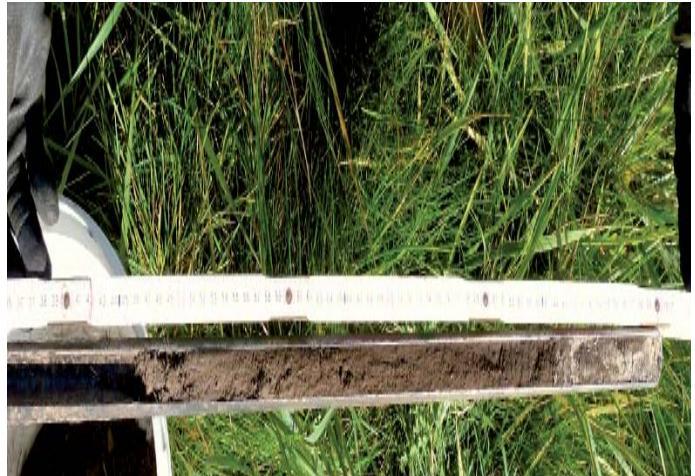
Fig. 5: Soil sampling at the research dike

In September 2014 the final investigation for chemical soil analyses at the Rostock test dike and pilot dike were carried out. The samples will be analysed until October and the results will show the risk potential through the applied dredged material and changes in the contents through application, weather conditions and repeated filling and infiltration at the test

dike. The samples will be analysed regarding heavy metals and organic contaminants as well as basic parameters like pH, TOC, lime content as well as salt and nutrient ions in solids and eluate.

The materials show higher salinity and organic matter content than traditionally used materials for dike construction founded by the origin in brackish water bodies. Thus there may be a need for the monitoring of the salt and nutrient ions if dredged material shall be applied. Heavy metals, on the other hand, only play a minor role during the potential leaching.

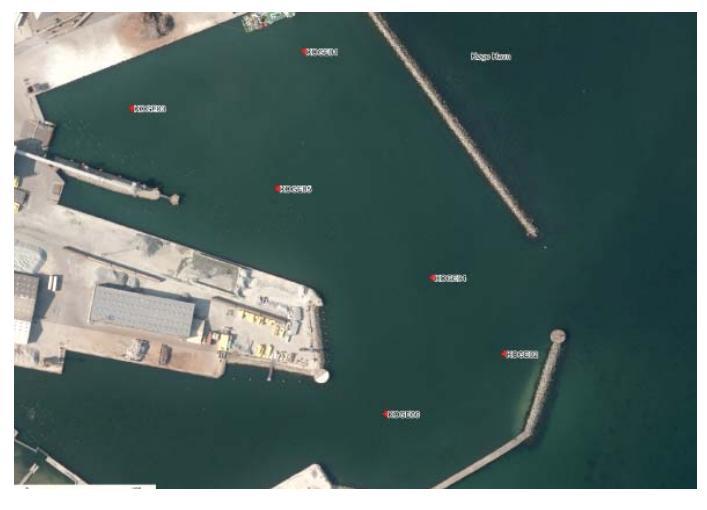
Fig. 7: Sampling locations in the port of Køge, Denmark

During the 3rd Mini-Call of the South Baltic Programme the DredgDikes project successfully applied for additional funding to perform investigations in Denmark. The marine investigations company Orbicon from Roskilde was contracted to take samples from six locations in the Danish Zealand region. The samples were analysed in the geotechnical
