Fig 1. Spoil field Schnatermann with marked heap complexes from 2009 (S2, S 3 and S4)

The pilot dike was built near the village Neu Heide at the Körkwitzer Bach (Fig. 1 and 2) about 30 km from Rostock. For the final investigation samples were taken all over the new dike surface up to the depth of 50 cm.

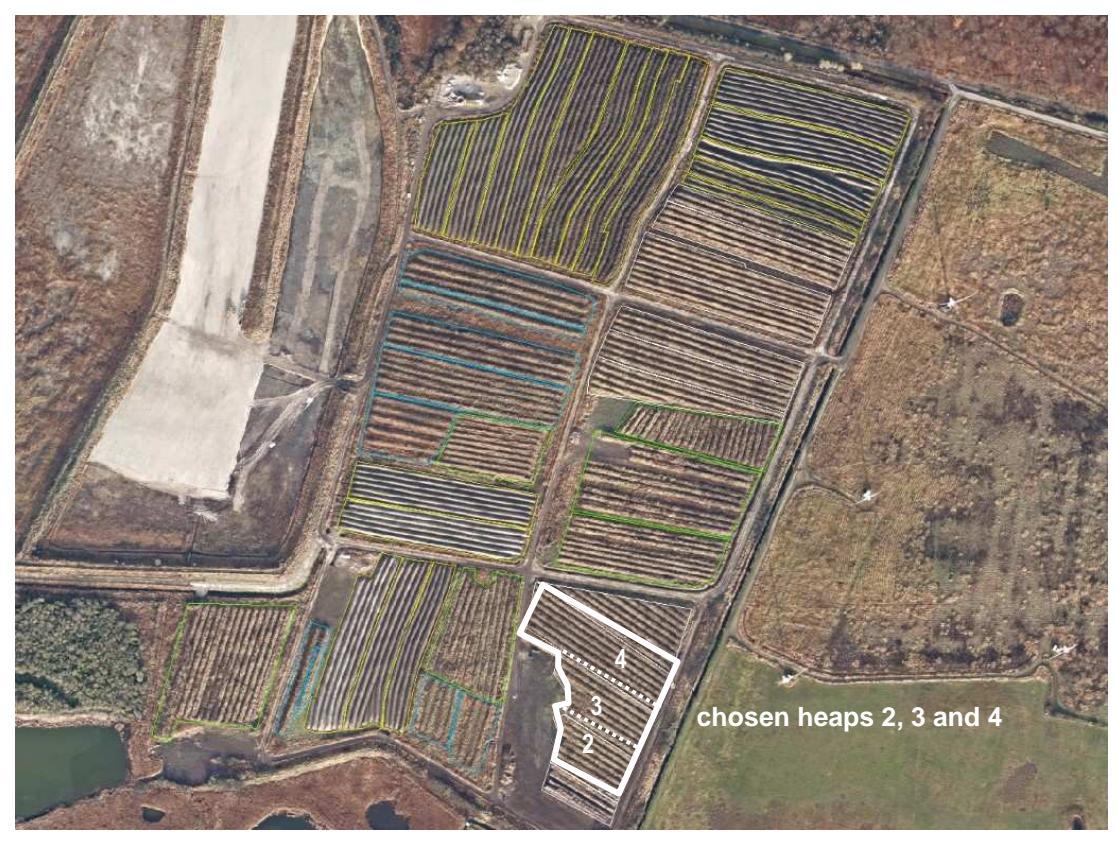
The examined heaps are on the spoil field complex Radelsee (Fig 1). The heap areas are opened by a flag road. The drainage of the heaps is made by a ditch system, which brings the water into the recipient outside of the pond dike. During the time of the first sampling relatively homogeneous substrate ranges (approx. 5 - 6,000 m <sup>3</sup>), separately according to sandy and poor in humus charges as well as in fine grained and rich in humus charges, were displayed.

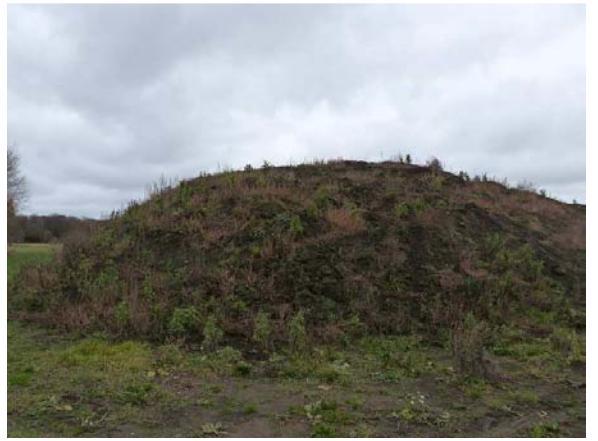
In summer 2013 the first m<sup>3</sup> of S2 were transported to the construction site and stockpiled for further use in autumn. The heap vegetated till in December 2013 the first application in the pilot dike was carried out (Fig 2 & 3).

Fig 2. Heap of material in Körkwitz, storage at the construction field since summer 2013

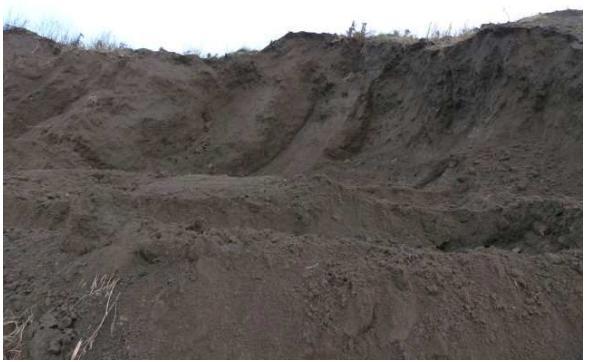
Fig 3. Material in December 2013 during the first application at the pilot dike

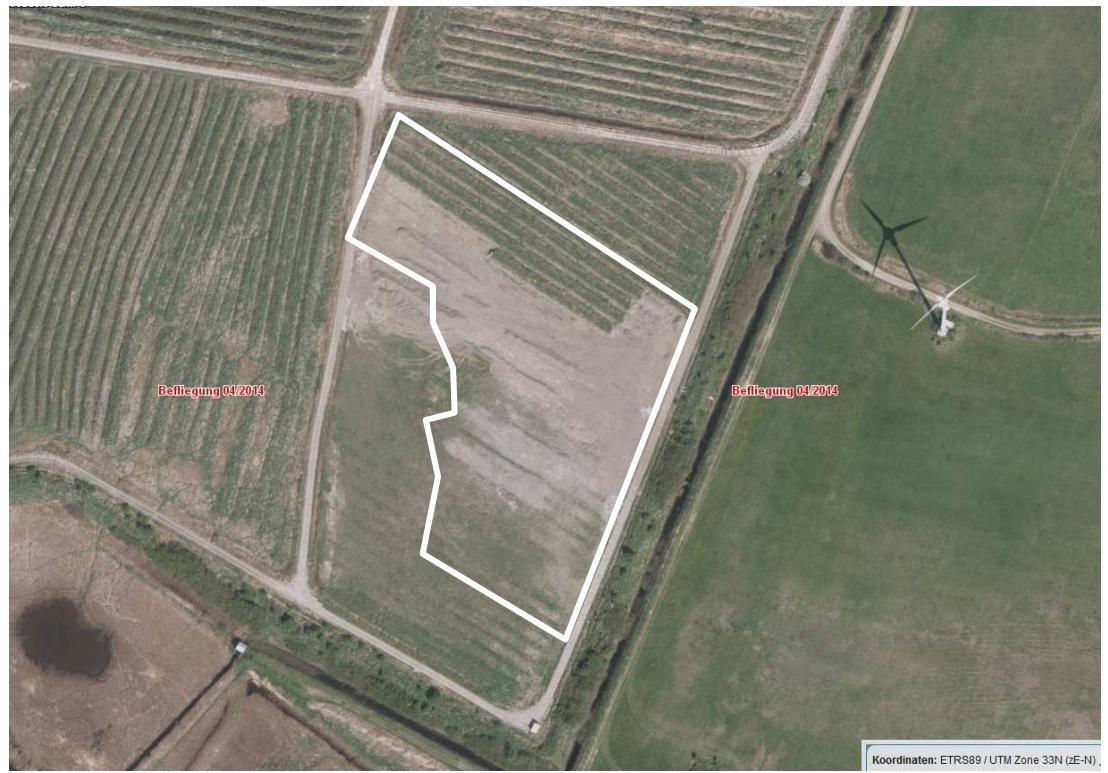
In spring 2014 the last material was transported to the dike construction site and the heap complex was almost cleared (Fig 4).

Fig 4. Cleared heap complexes in 2014 (S2, S 3 and S4)

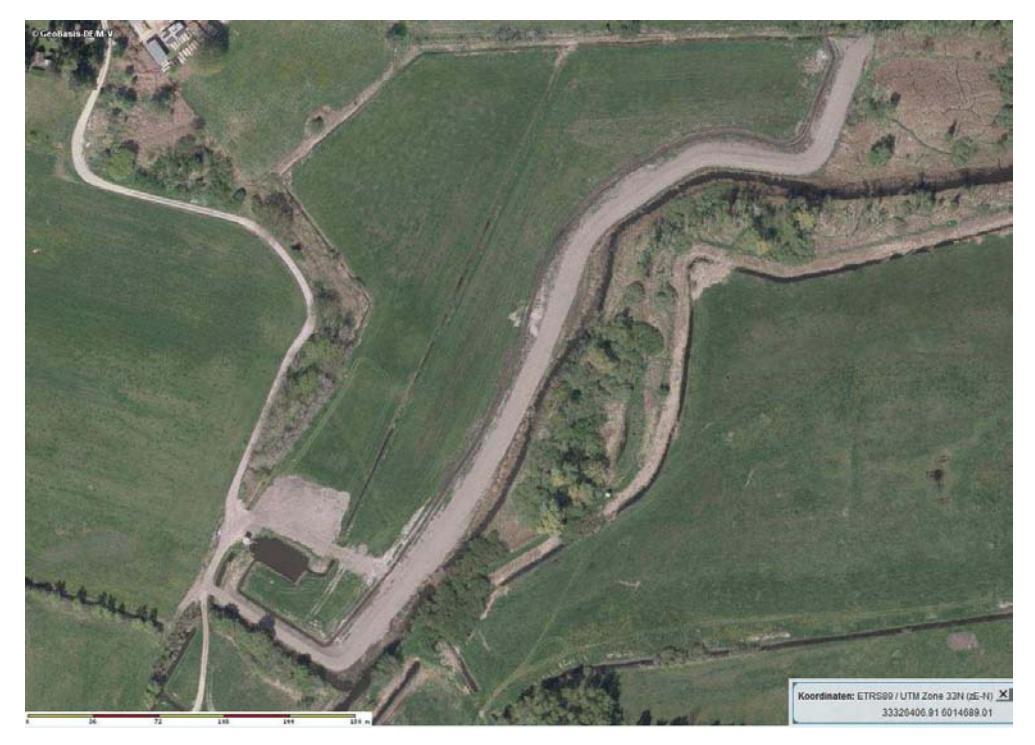
Fig 8. Constructed pilot dike in April 2014 (GAIA MV)

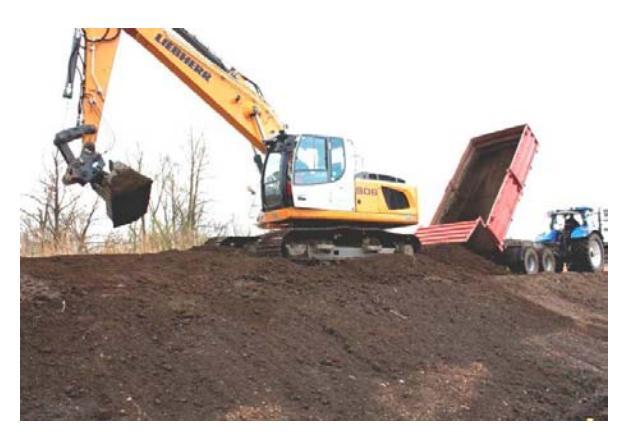
Fig 10. delivery of material for cubature

At first the compacted dike was stripped off soil material to get the right cubature (Fig 11). The surplus material was used to produce a crumbly surface at the pilot dike (Fig 12). In the most areas was a loose layer of 4 to 5 cm thickness. The sowing was done by hand with a seeding mixture with 60% *Festuca rubra*; 30% *Lollium perenne* and 10% *Poa pratensis*). The relative evenly spread seeds were raked in the loose dredged material (Fig 13). A rolling was not carried out. A starting fertilizer was avoided intentionally.

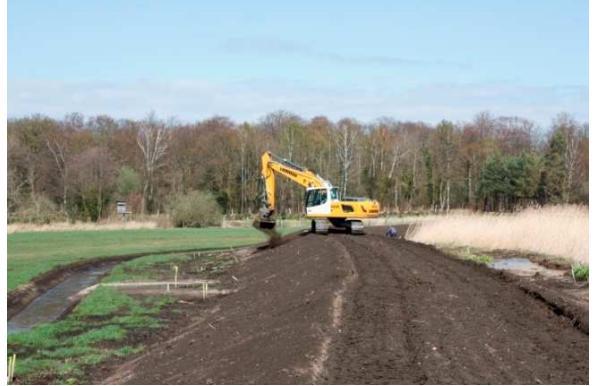
Fig 11. Fine crumbly material for the embankment

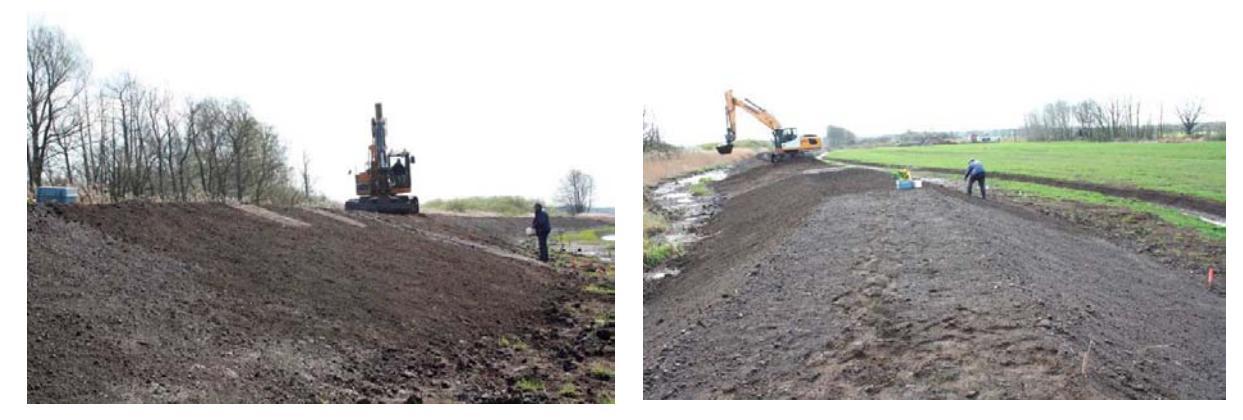
Fig 12. Fine crumbly seedbed before seeding

Fig 13. Seed raked in

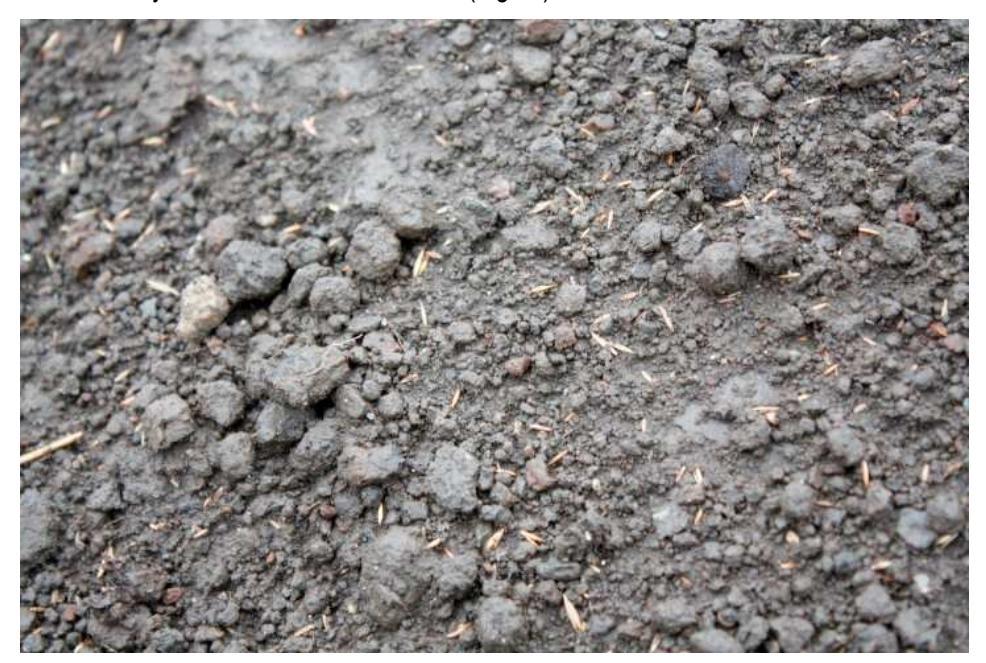
The weather conditions were quite good. At the beginning of April the soil temperature was too low for an optimal seeding time (should have about 8 °C). But the air temperatures got higher within some days and the dark dredged material could save the sun energy. The soil moisture was good. Only the wind was too strong for a good sowing by hand. The result of the seeding is to estimate as good. In large part the seed is covered slightly with soil, only few laid bare at the surface (Fig 14).

Fig 14. Seed mixture at the dike surface

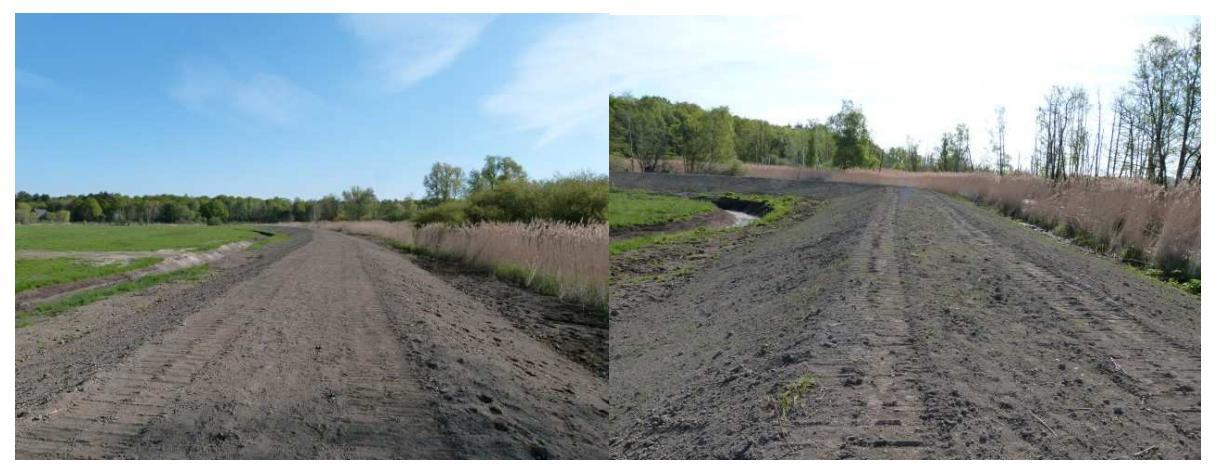
is about 40 mm. The germination of the grass was delayed. At the end of April a slightly green shine could observe in the section that was seeded at first. Only few grasses were visible at a whole overview (Fig 15).

Fig 15. a) First photo site with seeding at the 8th April.4. b) Third photo site with seeding at the 4th of April (Photo 29th of April)

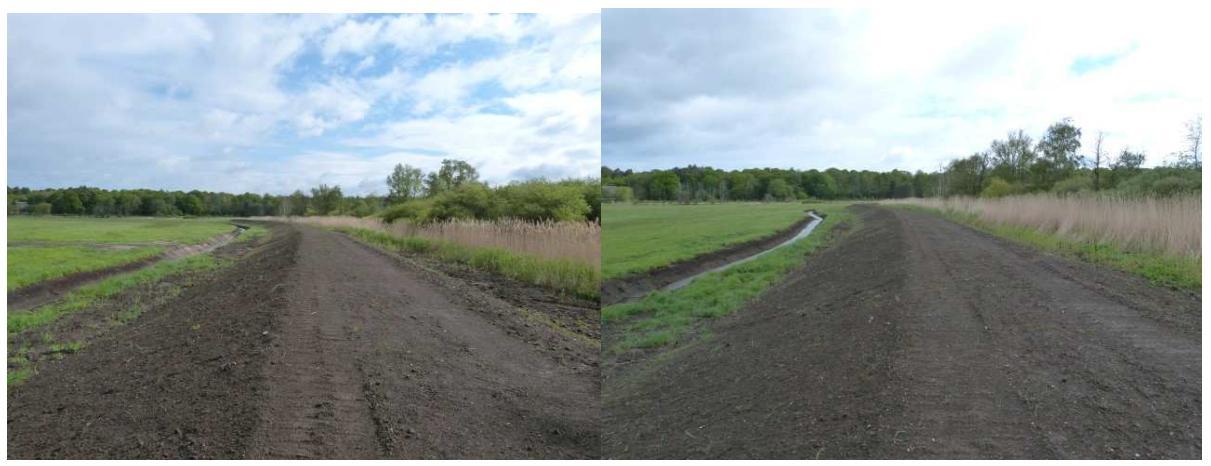
Fig 16. Photo at the 12<sup>th</sup> of May a) first photo site b) second photo site view in the North

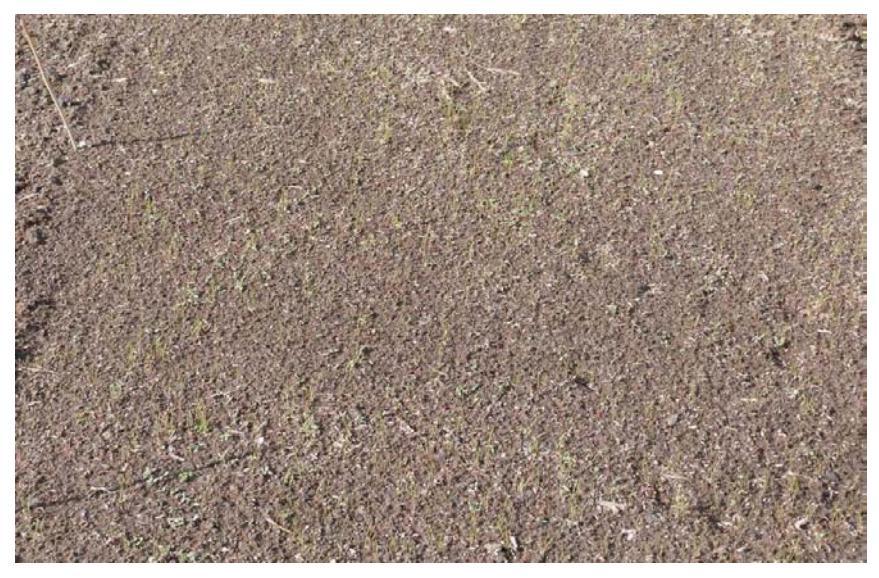
The delayed germination through missing moisture in the soil showed the lower embankment where trough ascending moisture the germination layer had a better water supply. After the precipitation of 30 mm between the 4<sup>th</sup> and 12<sup>th</sup> of May the grass germinated better (Fig 16). However, the germination of the seed was very hesitant and not covering a large area. But weeds like saltbush and quitch grew relatively fast at the seeded areas. In May also at the last seeded areas grass could observe. In the first section more grass showed and also the very compacted dike crest was green in many areas. Nevertheless, altogether the result of the seeding and the condition of the vegetation cover looked poor. In comparison at the 4<sup>th</sup> of April a small test area was installed at the treatment facility Radelsee where the same dredged material was checked for a grass seeding. At the 10<sup>th</sup> of April the first grasses germinate evenly over the test area (Fig 17).

Fig 17. Test area Radelsee grass spread at material S2 at the 10th of April, seeded 4th of April

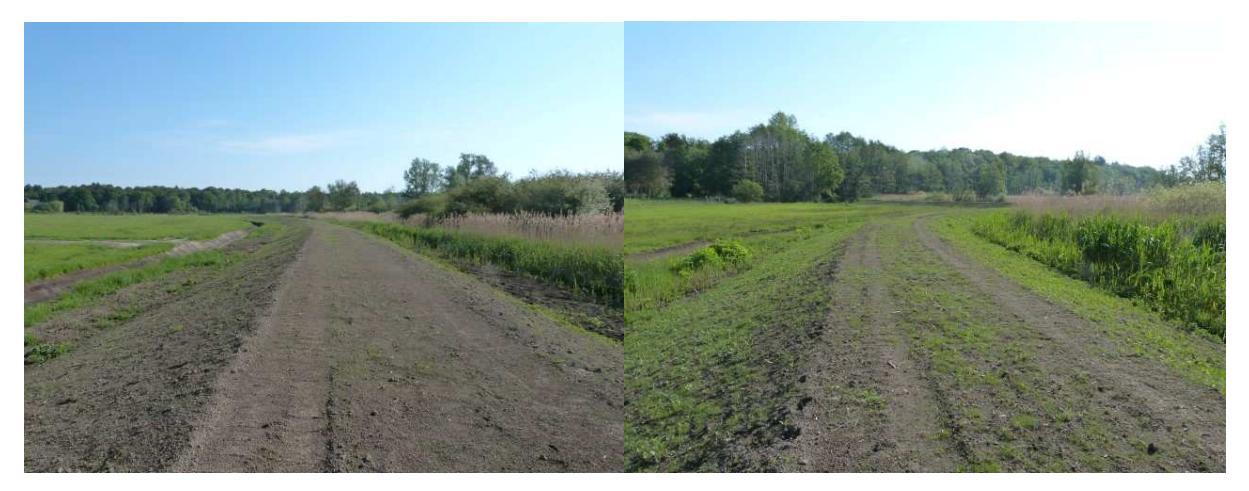
Fig 18 End of May a) second photo site b) third photo site

The inspection at the 21th of May (Fig 18) was followed by a dry and very warm period and with it an increased drying of the surface. The growth of the turf stagnated. After the 5th of June and the following 11 days over 40 mm rainfall was measured and the vegetation growth, unfortunately also the weeds.

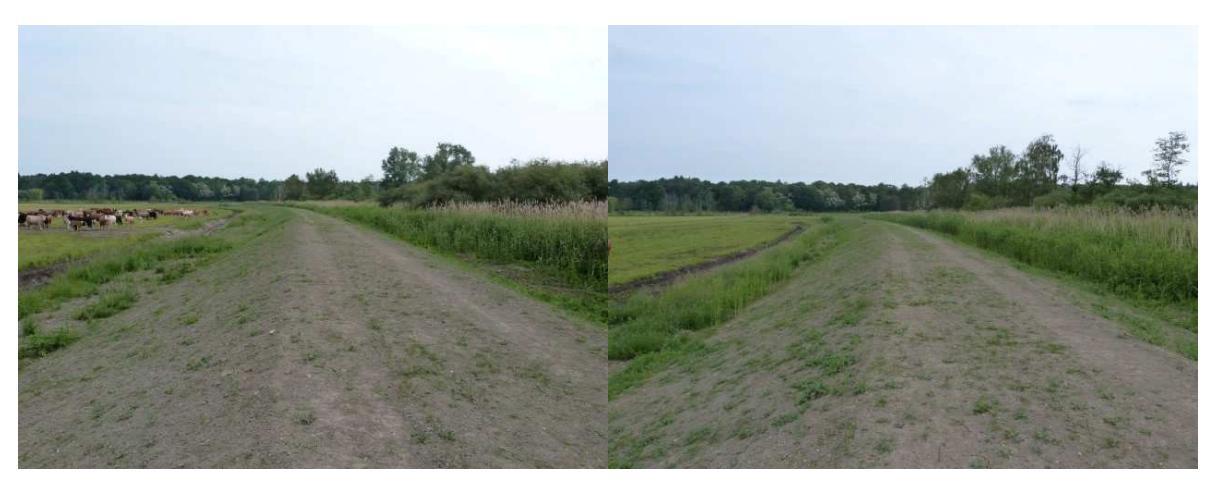
In June the germination of grass remains static (Fig 19). In spite of grass a lot of weeds germinated and grew higher and covered in some areas the surface and repressed the grass.

Fig 19. Germination remain static, high weed pressure at the beginning of June a) 1th site b) 2nd site

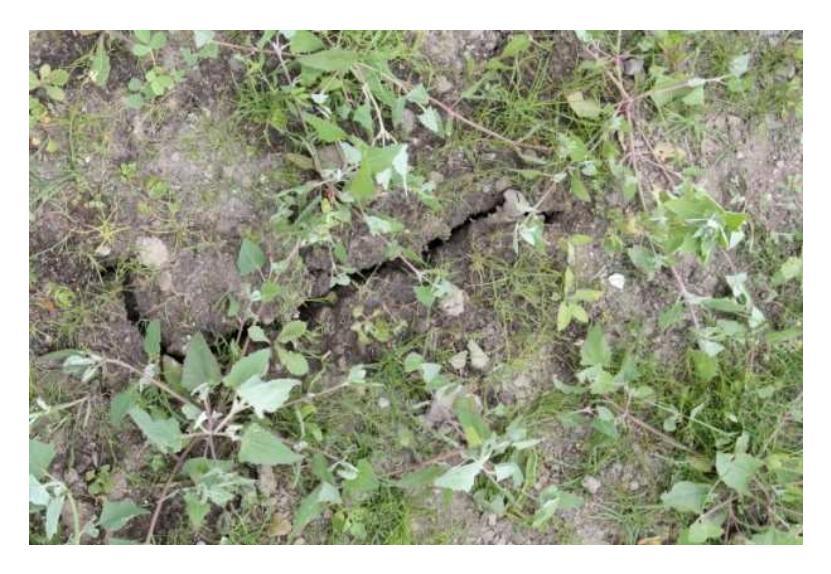
Since this time period the wild plants dominate. The turf got less light and suffered in its growth under the pressure of the weed (Fig 20). At this time a deep cut of the weed would be necessary with a mower which cut the grass about 5 - 10 cm above the surface. So the weed could remove and the grasses could get enough light for growing. In the first decade of July the weed vegetation at the embankments was about 50 cm high (Fig 21). However, in the areas with less weed which covered the surface also the turf developed only hesitant (Fig 22).

Fig 20. Grasses and Salt bush struggle for water and light; cracks at the dike surface swallow the rain but also evaporate much

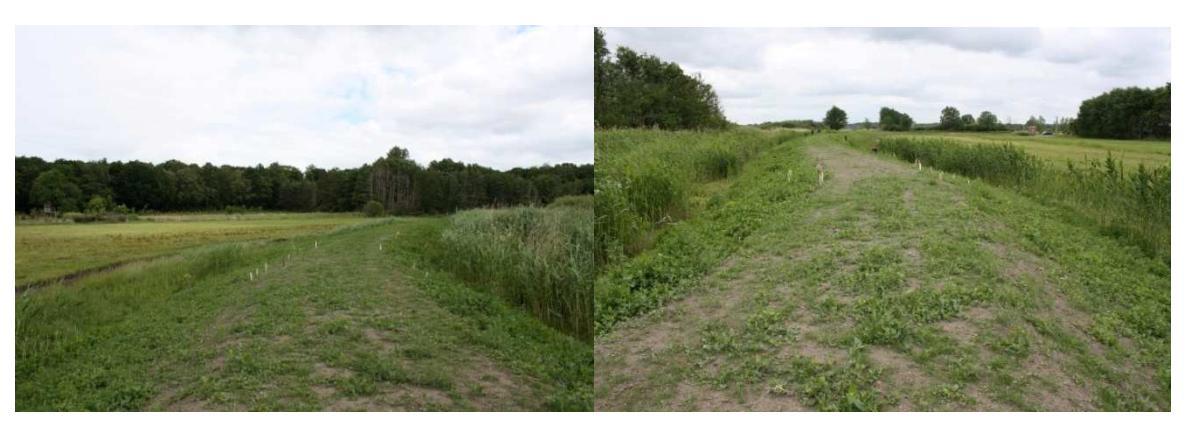
Fig 21. No close vegetation cover mid June, grass growth delayed a) 3rd site b) look back 3rd site

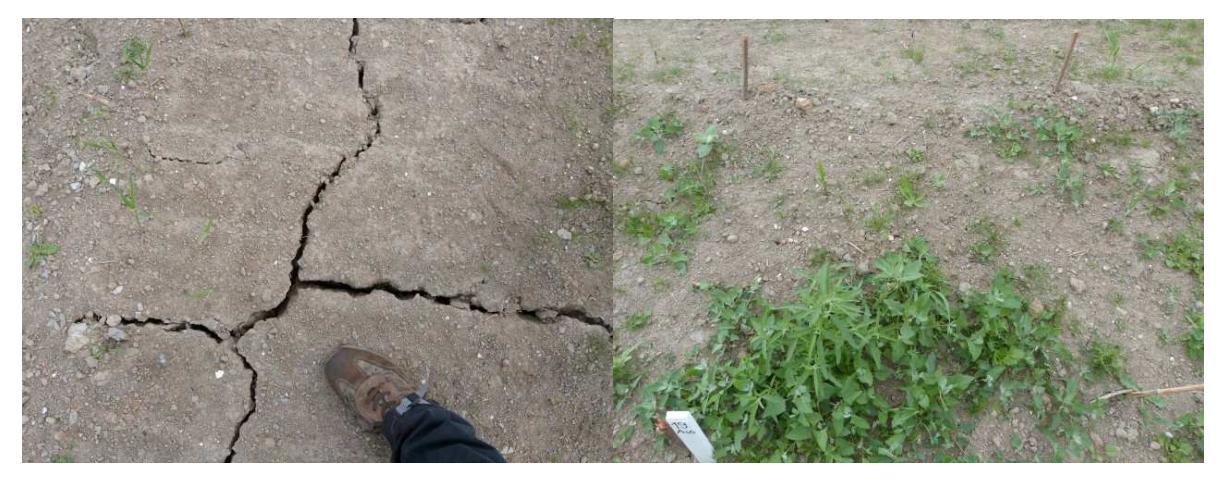
Fig 22. a) Cracking at blank and compacted areas at the crest b) Increased growth of salt bush

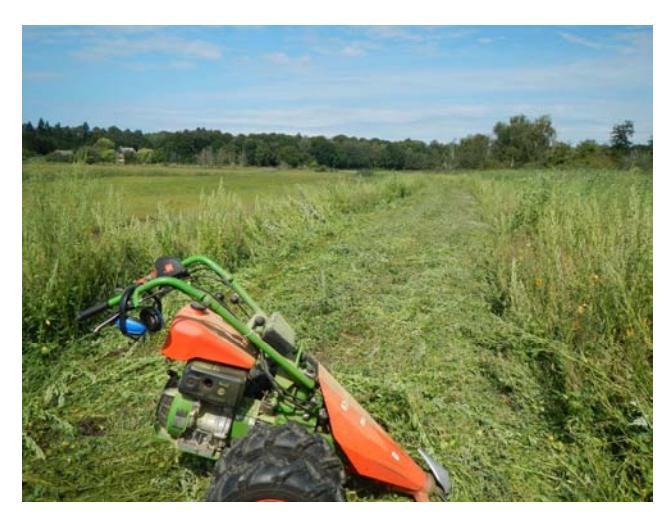
Because of organization problems the deep cut was carried out delayed in the beginning of August from the water and soil agency (Fig 23). The population of weed like reed and saltbush as well as mugwort etc. was at the embankments more than 1 m high.

Fig 23. High vegetation at the pilot dike 5<sup>th</sup> of August; mowing of the crest

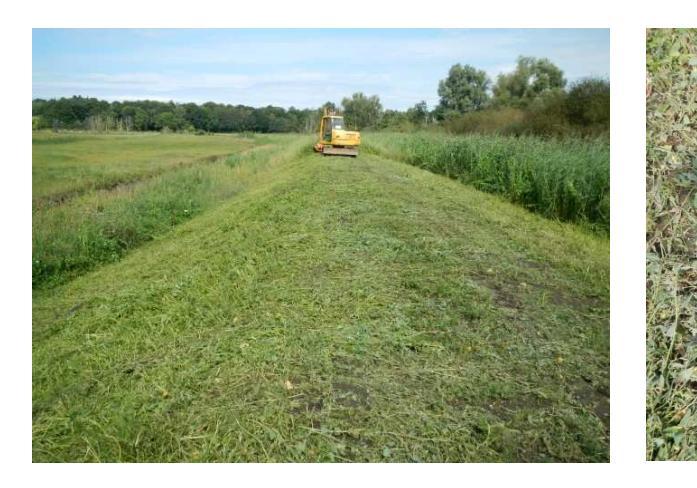
Fig 24. Mowing of the embankmants

At the beginning of August the pilot dike was mowed with mulching technique (Fig 24/25). The mowing rests were for mulching. This is a common procedure to leave the mowing rests and to use them like a fertilizer if a mowing will repeated all second weeks again. If the growth of grass is only small there will be no problem. The grass can grow through the dry rests. If the growth of the grass and the weeds is very high and thick a mulching is not advisable. The DIN 19712 for river dikes recommended that the mowing rests should deleted from the dike surface to prevent surface defects. A control visit (12<sup>th</sup> of August) confirmed that the salt bush and reed rests as well as other weeds were very compact and were repressing the grass mainly at the embankments. Greater areas of the dike embankment - altogether the areas with high pressure from the weed - were without turf at this time (Fig 26).

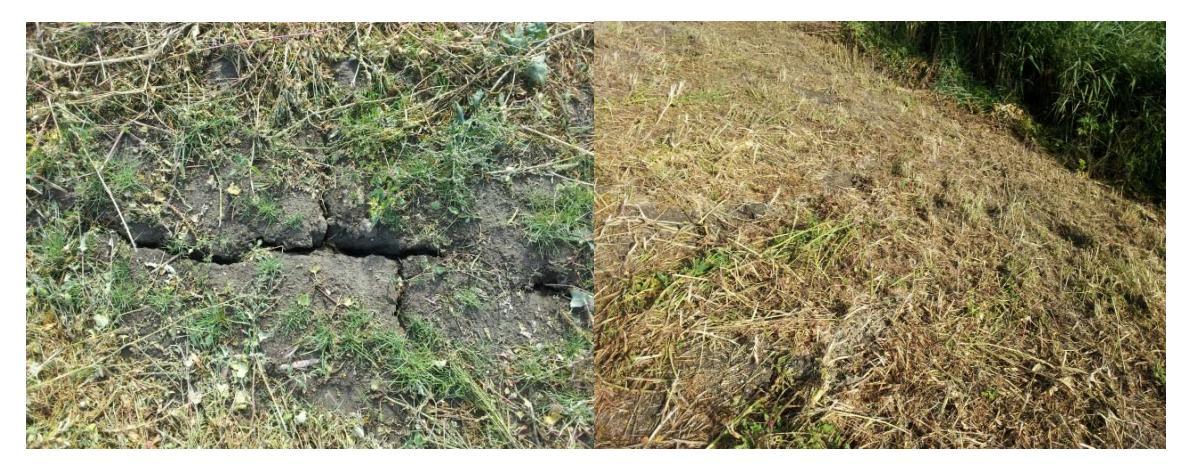
Fig 26 a) Spare turf b) cut dried vegetation one week after mowing

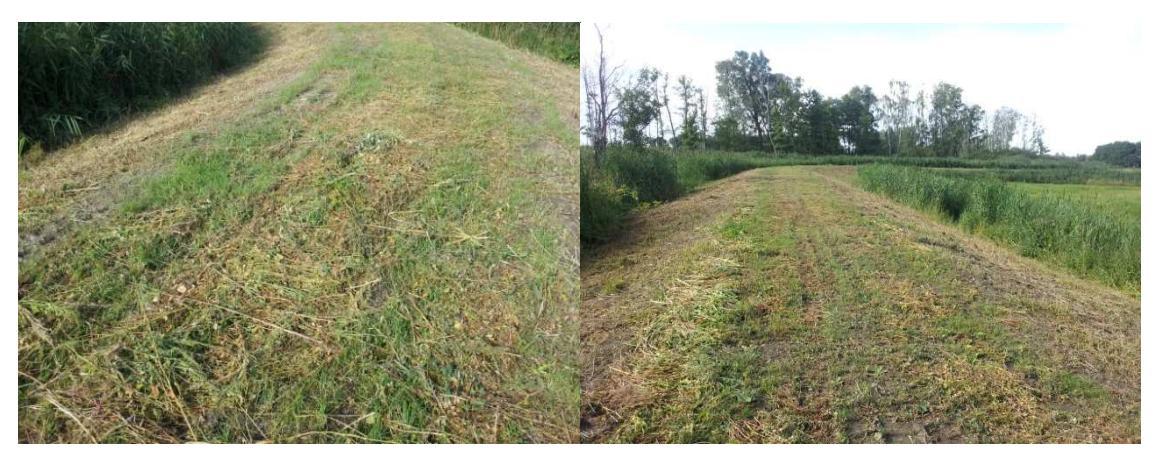
At the dike crest the mowing rests were almost insignificant. Here the grass looked a bit closer too (Fig 27).

Fig 27. Dike crest a) detail b) 3rd photo site looking back

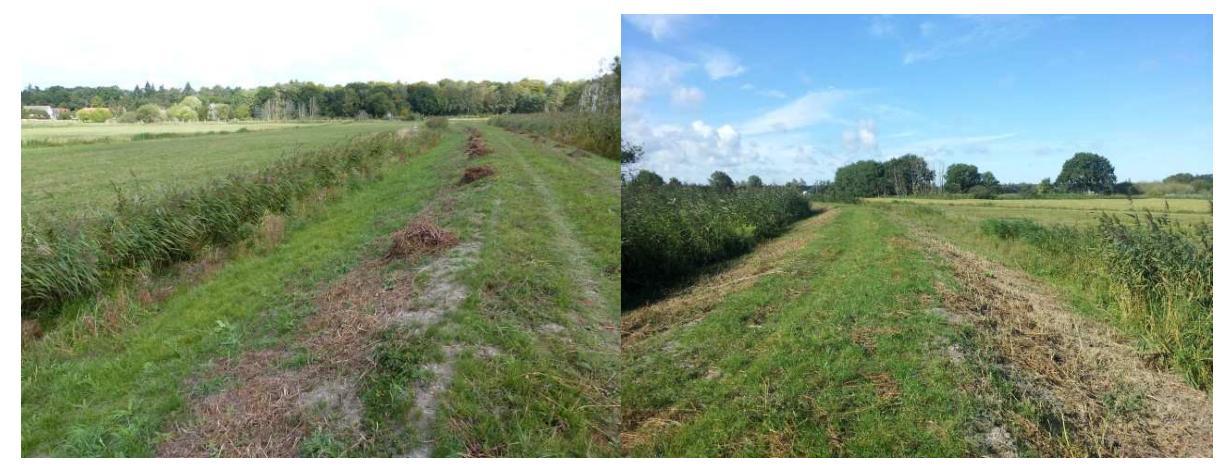
The removing of mowing rests in the beginning of September brought light up to the bare areas where the saltbush and other weeds covered the seeded grass (Fig 28).

Fig 28. Removing of mowing rests and recovery of the turf a) 2<sup>nd</sup> site b) 2<sup>nd</sup> site looking back

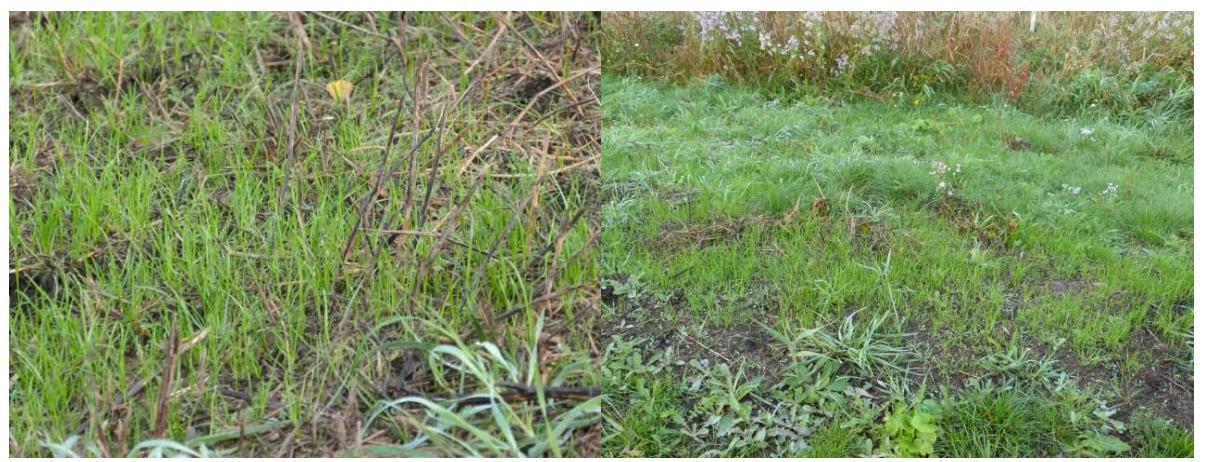
Thanks to a long decade with wet and warm conditions from begin of October to mid November many remaining and some newly seeded grass germinate fast. And within November an almost closed turf developed. Mid November the pilot dike is in a good status and looks altogether green and vital. The bare spots are almost closed (Fig 29, 30 and 31).

Fig 29. a) New spreading grass b) bare areas are closing

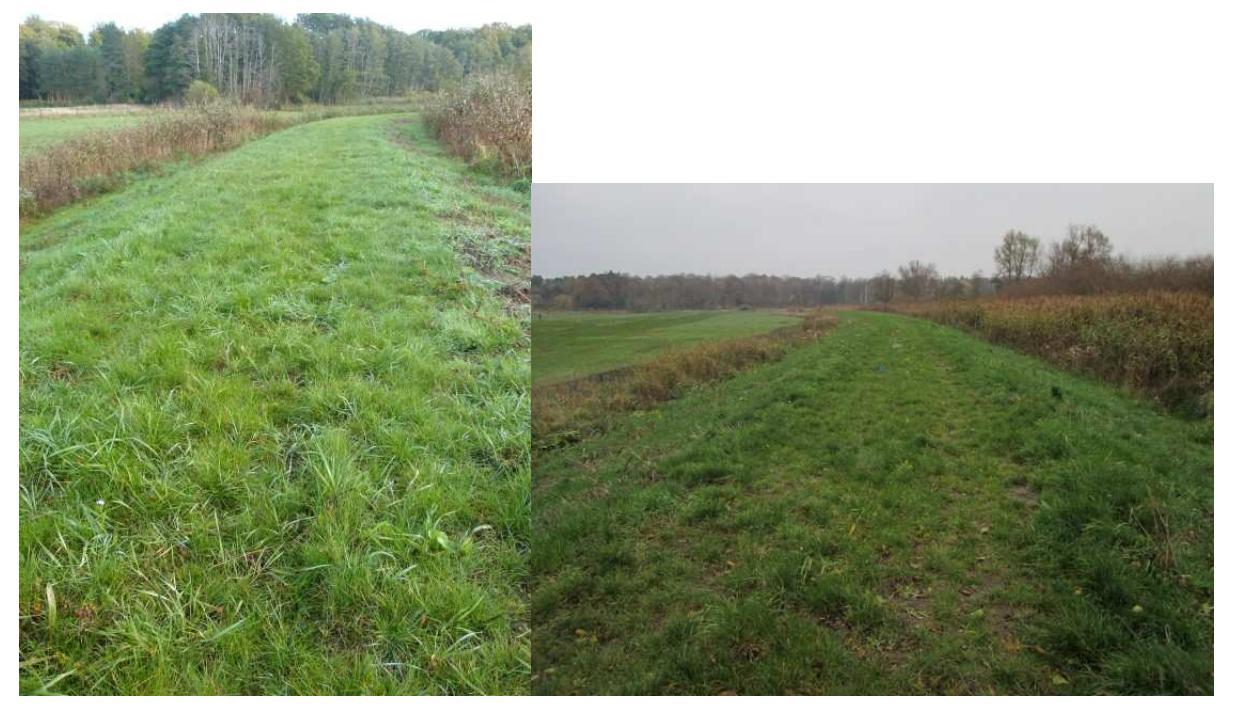
Fig 30 a) 2<sup>nd</sup> / 3<sup>rd</sup> photo site mid November b) 2<sup>nd</sup> site end of November

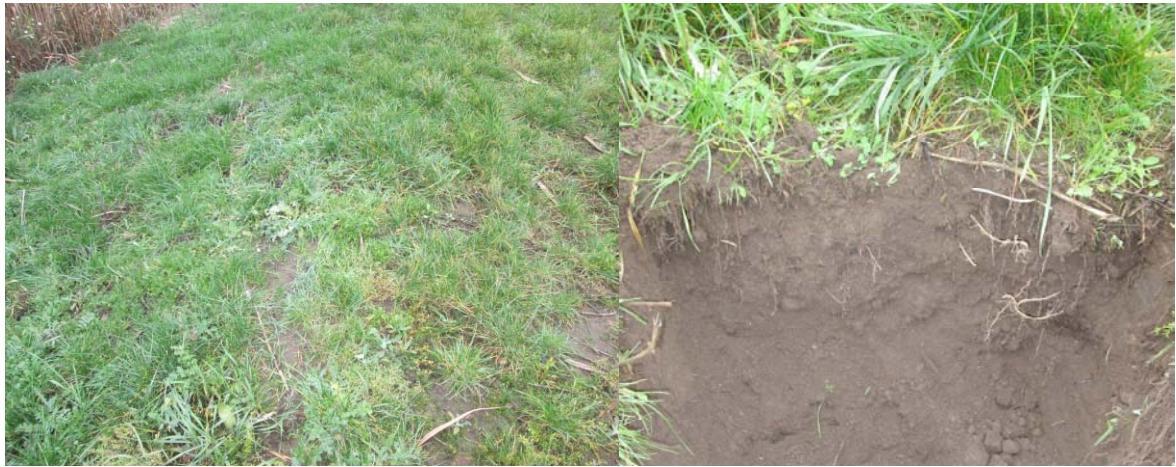
Fig 31. End of November a) closure of blank spots b) rooted top soil
